<b>Case study #</b>	1.12
<b>Title</b>	TV interference problem due to telecommunication equipment
<b>Type of trouble</b>	Disturbance.
<b>Source of trouble</b>	Radiated emission.
<b>System affected</b>	TV receiver.
<b>Location</b>	Outdoors (near telecommunication centre or remote site).
<b>Keywords</b>	Radiated emission, TV receiver.
<b>Version date</b>	2008-02-29

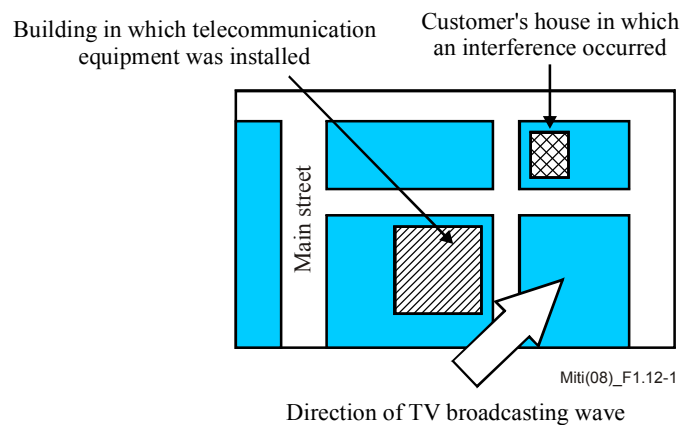
**Figure 1.12-1 – Map of the EMI problem**

A map of the location of this problem is shown in Figure 1.12-1, where the TV broadcast wave was propagating from the bottom-left to the upper-right domain. The TV receiver that experienced interference was installed just behind the building where the telecommunication equipment was set.

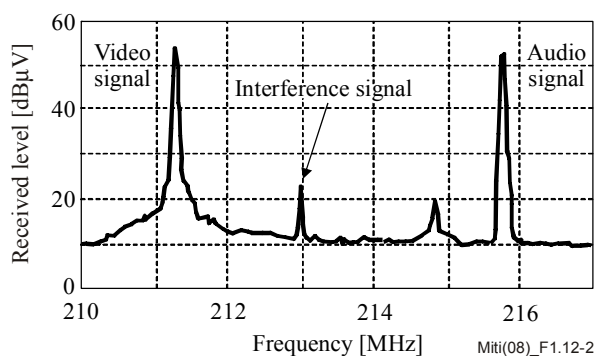
**Figure 1.12-2 – Measured result of received signal level**

The received level of the TV broadcasting waves was measured with a spectrum analyser connected to a TV antenna at the customer's house. Figure 1.12-2 shows the measured frequency spectrum at the customer's house. An interference signal existed between the video and audio signal bands, and its level was about 22 dB $\mu$ V. One can see that the D/U (desired/undesired) signal ratio was about 30 dB. From the experience of similar EM problems, the required level for the D/U ratio should be greater than 40 dB. Therefore, it was considered that this interference signal influenced the TV receiver, resulting in the generation of stripes on the screen.

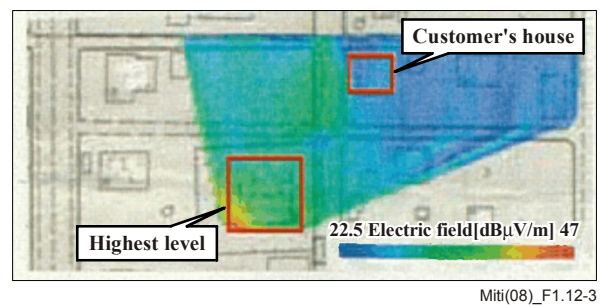
**Figure 1.12-3 – E-field distribution near the customer**

Figure 1.12-3 shows the results of measuring the electric field distribution around this location. The results indicate that the highest electric field strength was observed near the building and that the measured level tended to decrease as the distance from the building increased.

As a result, it was confirmed that the disturbance came from the building in front of the customer's house. The source of this interference was investigated and it was found that the interference signal radiated from transmission equipment in the building.

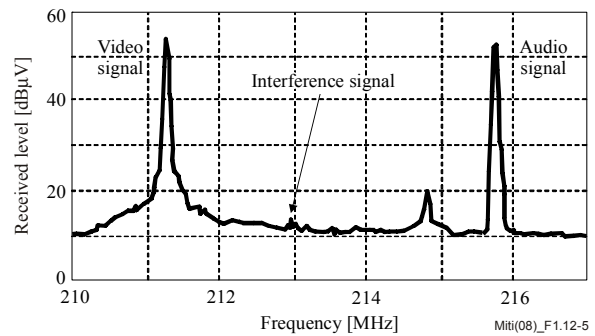
**Figure 1.12-5 – Measured spectrum after countermeasures**

After taking these countermeasures, the level of the interference signal decreased from 22 dB to 11 dB. As a result, the D/U ratio became more than 40 dB and the TV interference disappeared (see Figure 1.12-5).
