| <b>Case study #</b> | 1.2 |
| <b>Title</b> | Acoustic noise troubles caused by switching noise of digital subscriber unit (DSU) |
| <b>Version date</b> | 2004-01-01 |

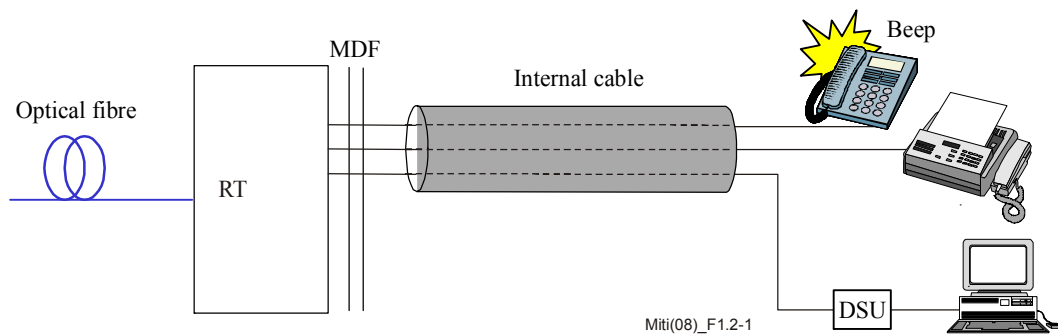
**Figure 1.2-1 – System configuration**

Acoustic noise trouble occurred at a customer's premises. The system configuration is shown in Figure 1.2-1. A remote terminal (RT) was used, as well as single mode fibres for the trunk lines. Metal lines were distributed using a metallic internal cable. Telephones, facsimile machines, and DSU were connected to the cable. There was no radio base station around the location. The electric field strength was not so high. After an ISDN service was introduced, the acoustic noise problem occurred. The line connected to the telephone was changed; however, the noise problem still continued.

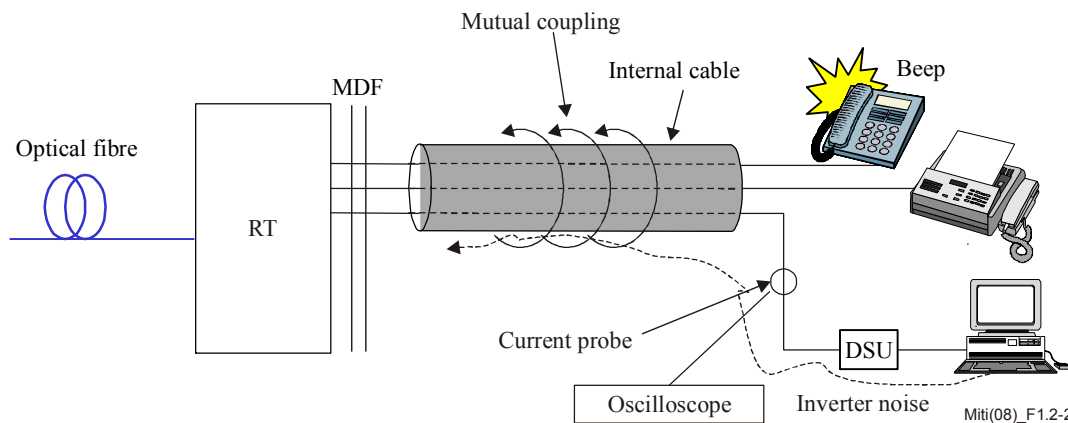
**Figure 1.2-2 – Measurement of noise current on lines**

To identify the noise sources, electric current wave shapes were measured using a current probe as shown in Figure 1.2-2. First of all, the current in the line connected to the telephone where the acoustic noise problems occurred was measured. The current level was not high but could cause malfunction of the telephone. However, the wave shape had little relation with the telephone because inverter noise spectrum was included in the wave shape. Next, the current on the line connected to the DSU was measured (see Figure 1.2-3). The current level was  $240 \text{ mA}_{\text{p-p}}$ , which is not a low level. As a result of the investigations, it was confirmed that the electric current noise originated at the DSU power source because the noise disappeared when the DSU was turned off. The noise current from the DSU travelled over the internal cable. In the cable, mutual coupling phenomena occurred. The noise current from the DSU induced noise current on the line connected to the telephone. The current caused malfunction of the telephone and the noise was detected in the telephone.
