<b>Case study #</b>	1.3
<b>Title</b>	Acoustic noise troubles caused by switching noise of an elevator (lift)
<b>Type of trouble</b>	Acoustic noise.
<b>Source of trouble</b>	Elevator.
<b>System affected</b>	Customer's equipment.
<b>Location</b>	Customer premises.
<b>Keywords</b>	Elevator, mutual coupling, switching noise.
<b>Version date</b>	2004-01-01

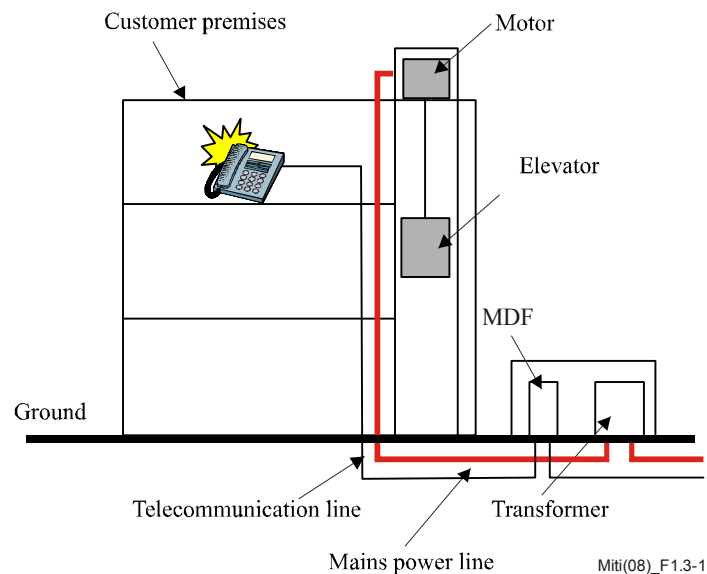
**Figure 1.3-1 – System configuration**

Acoustic noise trouble occurred at a customer premises. The customer complained that the acoustic noise could sometimes be heard; however, it was not clear what the trouble source was. The system configuration of this issue is shown in Figure 1.3-1. At the customer premises, the telecom lines and power mains cable for the elevator (lift) were parallel in the cable duct. The motor of the elevator used a switching power source. The telecom line connected to the telephone set was also connected to the MDF where the power transformer was located. The telecommunication line was changed; however, the acoustic problem continued.

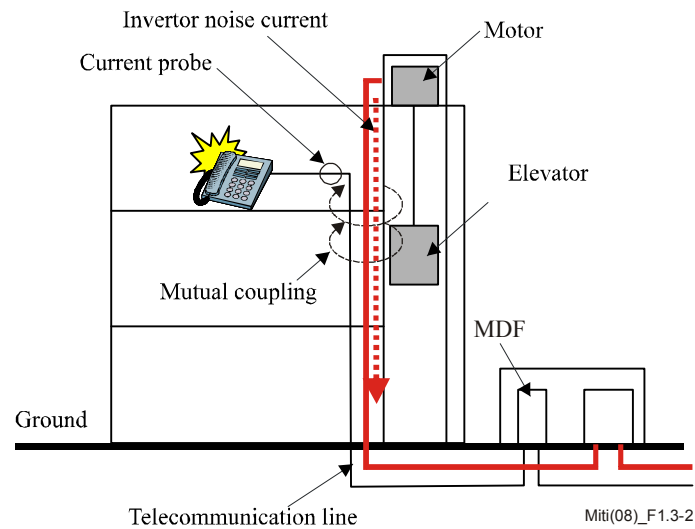
**Figure 1.3-2 – Measurement of noise current**

To solve this acoustic problem, the current in the telecommunication line was measured (Figure 1.3-2). The common mode current wave shape is shown in Figure 1.3-3. A typical period 200-300  $\mu\text{s}$  periodic characteristic can be seen in the figure. Its major frequency is about 5 kHz and it was estimated that the noise source must be a switching power source. The investigations showed that the power mains cable was wired parallel to the telecommunication line, and that the telecommunication line was connected to the main distribution frame (MDF) room, where the mains power transformer was located.
