| <b>Case study #</b> | 1.4 |
| <b>Title</b> | Emission from telephone equipment affecting an amateur radio |
| <b>Type of trouble</b> | Acoustic noise. |
| <b>Source of trouble</b> | Host equipment of telephone system. |

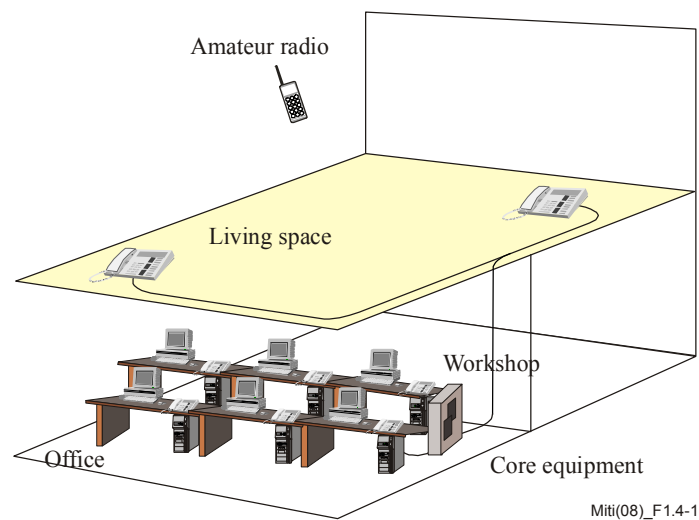
**Figure 1.4-1 – System configuration**

Acoustic noise interference occurred in an amateur radio installed on the second floor of a building (see Figure 1.4-1). The building's first floor is an office and workshop and the second floor is a living space. The affected frequencies were 145.00 and 144.00 MHz. A lot of office equipment and manufacturing equipment was installed on the first floor. The distance between the amateur radio and the noise source (core equipment) was 10 m.

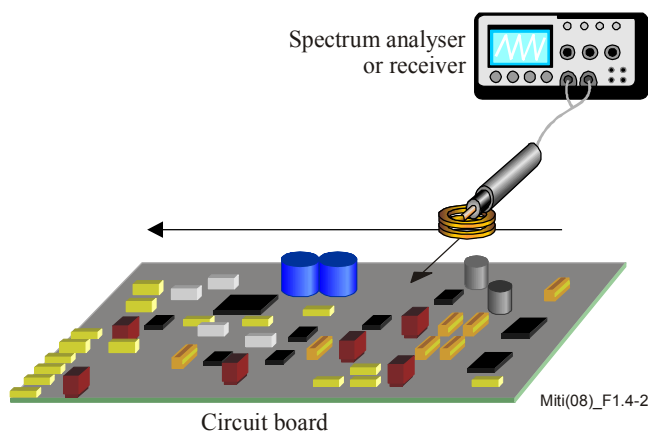
**Figure 1.4-2 – Searching for the noise source**

- a) The system was measured in an anechoic chamber and the noise level was checked.
  - b) The noise source was searched for using a near-field magnetic probe and a spectrum analyser, as shown in Figure 1.4-2. In this case, a probe (Figure 1.4-3) was used. This probe had a coil consisting of several turns installed ahead of the coaxial cable. The coil was connected between the inner and outer conductors. Areas close to board components IC8 and Xtal4 had higher noise levels.
  - c) The noise level was checked by trial and error in an anechoic chamber when a mitigation device such as a capacitor or ferrite core was installed.
