Case study #	1.5
Title	Acoustic noise troubles caused by an electric fence
Type of trouble	Acoustic noise, degradation.
Source of trouble	Electric fence.
System affected	Customer equipment, line.
Location	Customer premises, outdoors.
Keywords	Power transmission line, transformers, screening, mutual coupling earth connection, optical components, optical insulation.
Version date	2004-01-01

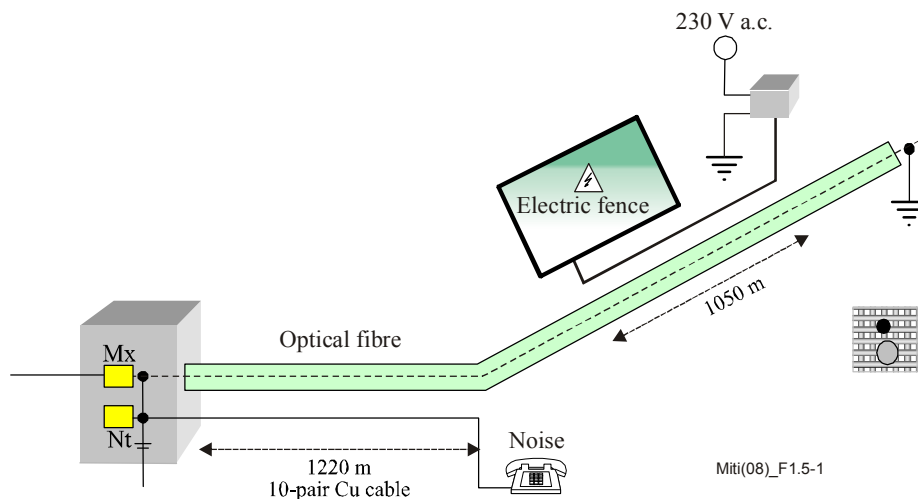
An optical fibre cable, with its screen earthed at both ends, was running parallel to the 10-pair copper cable. The optical fibre cable, the multiplexer (optical-electrical) and the 10-pair copper cable ended at the same distribution point. However, a long electric fence was located in the neighbourhood of the optical fibre cable, although not at the copper cable site.

Figure 1.5-1 – System configuration

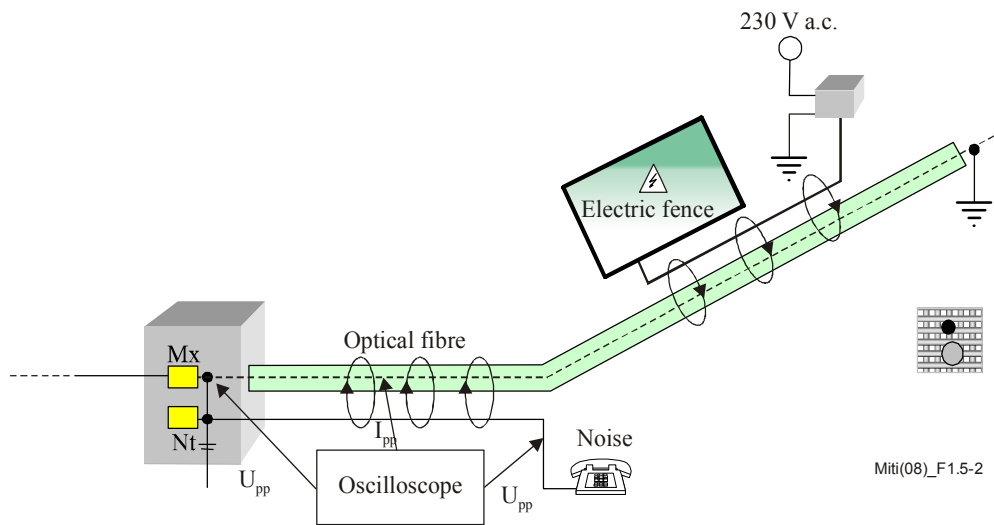
The electric parameters of the line were in line with the requirements. A 148-Vp-p longitudinal voltage line-to-ground at customer installation was measured (Figure 1.5-2). The major frequency of the transients was about 8 kHz and decreased after 2.5 ms (Figure 1.5-3). The transients repeated at 1.3-second intervals. Measurements were also made at the distribution point. On the screen of optical fibre transient, currents with about 27 Ap-p were measured. The peak-to-peak voltage recorded between the earthing conductor of the screen and the ground at the distribution point was 340 Vp-p (Figure 1.5-4). The asymmetrical supplying cable of the electrical fence, which was situated along the route of optical fibre, was identified as the source inducing the transients.

Figure 1.5-2 – Measurement system

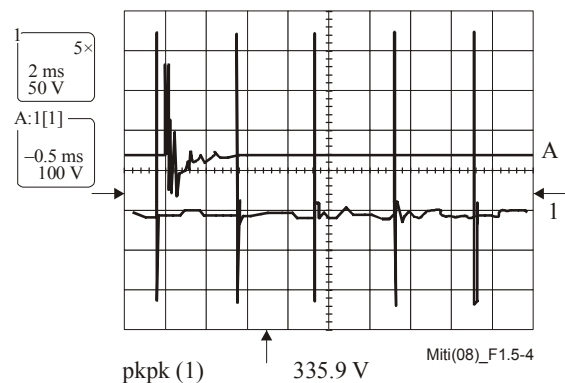
Through the screen that was earthed at both sides (screen resistance 13.5Ω), the optical fibre was the source for the induction into the parallel copper cable. The metallic foil of the 10-pair cable was earthed on only one side, connected to the earth of the distribution point.

Figure 1.5-4 – Voltage transient on the screen of the optical fibre

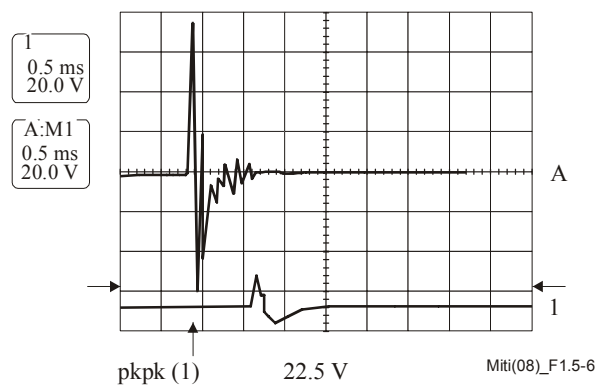
Figure 1.5-6 – Mitigation results

First, the metallic foil of the 10-pair copper cable was connected to the main earthing terminal at the customer site. As a result, the transient voltages were reduced to 1/6 of the value that had before mitigation (Figure 1.5-6). The remaining voltage, which was about 23 Vp-p, still caused some clicking noise. To solve this problem, it was decided to install a neutralizing transformer at the distribution point. This led to a decrease of about 3 Vp-p, making the disturbance vanish.
