Case study #	2.6
Title	Lightning damage to a payphone
Type of trouble	Damage.
Source of trouble	Lightning.
System affected	Customer equipment (Payphone).
Location	Outdoors (in the street or in a campus).
Keywords	Damage, lightning surge, bonding, protection coordination, GDT.
Version date	2004-01-01

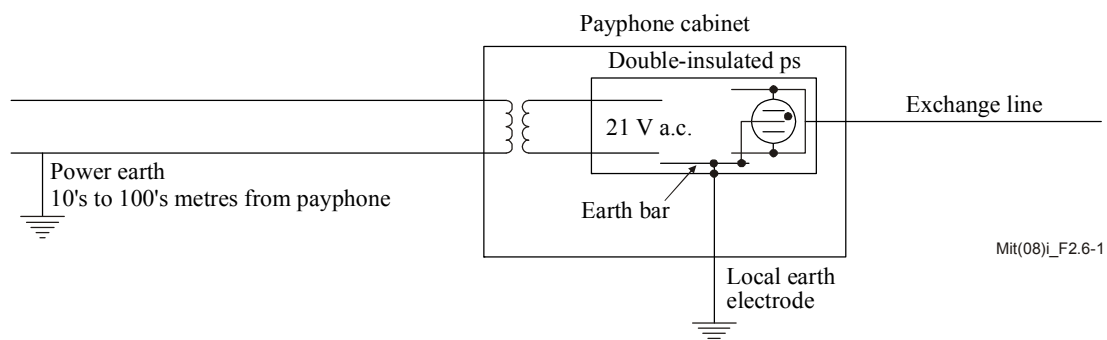
Figure 2.6-1 – System configuration

The problem equipment is a payphone in an outdoor cabinet installed in a university campus. The earth for the mains supply to the payphone cabinet was tens of metres away from the cabinet. The local earth for the cabinet is 10s of ohms. Inside the cabinet is a double-insulated power supply which supplies 21 V a.c. to power the payphone. The payphone has a local earth for coin metering and lightning protection of the payphone electronics and users. Components were being physically damaged in the equipment. It was assumed that lightning was causing this damage. The system configuration is shown in Figure 2.6-1.

It is assumed that a lightning surge on the mains exceeds the breakdown voltage of the power supply transformer (8 kVd.c.) and injects current limited surges into the payphone 21 Va.c. power supply. This type of damage was not detected during testing of the mains input at 6 kV 10/700 μ s (enhanced inherent mains port test).
