Case study #	2.8
Title	Earth wire voltage drop in telecommunication centre
Type of trouble	Damage.
Source of trouble	Lightning.
System affected	Transmission equipment.
Location	Telecommunication centre.
Keywords	Damage, lightning surge.
Version date	2004-01-01

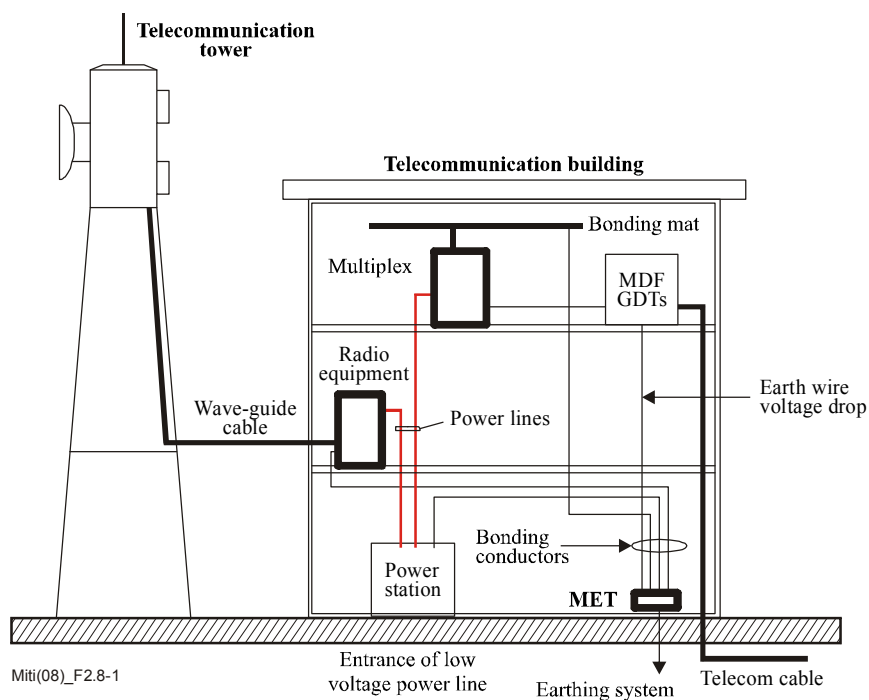
Figure 2.8-1 – Radio station

During thunderstorms, several line cards of a multiplex, located in a radio station, were frequently damaged.

Located on the top of a mountain, the radio station is composed of a 40-m high telecommunication tower and an adjacent 2-floor building (Figure 2.8-1). The antennas on the tower are connected to the radio equipment inside the building by wave-guide cables.

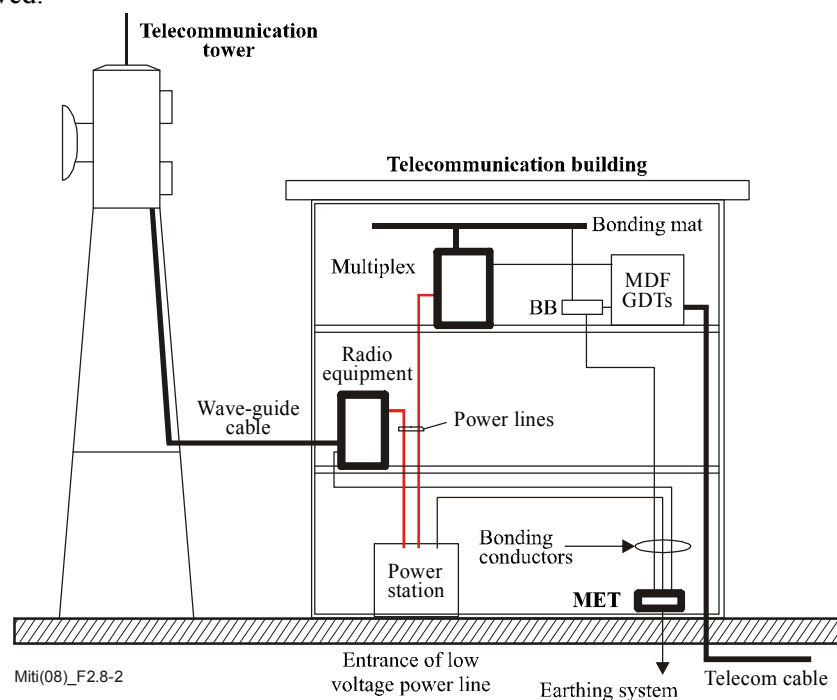
Figure 2.8-2 – New bonding configuration

In this installation condition, when overvoltages cause GDTs firing, the voltage drop, caused by the overcurrents flowing in the bonding conductor between the MDF and the MET, will appear at the entrance of the line cards and could cause damages if its peak value is greater than the line card resistibility level defined by Rec. ITU-T K.45 or Rec. ITU-T K.20.

Because the earth wire voltage drop was probably the source of the line-card damages, the equipotential bonding technique was improved in order to prevent the earth wire voltage drop from being transferred to the equipment interface.

This was easily achieved by installing on the second floor another bonding bar (BB) connected to the MET. The metallic structure of the MDF (i.e., the GDTs' earth) and the bonding mat were directly connected to the second floor's bonding bar.

This installation avoids transferring the earth wire voltage drop to the equipment interface and there is no need to limit its value or to increase the line-card resistibility to lightning overvoltages.
