Case study #	2.9
Title	Malfunction of circuit breaker due to lightning surges
Type of trouble	Abnormal operation.
Source of trouble	Lightning.
System affected	Access system.
Location	Outdoors.
Keywords	Safety, immunity, lightning, power transmission line, circuit breaker, MOV.
Version date	2004-01-01

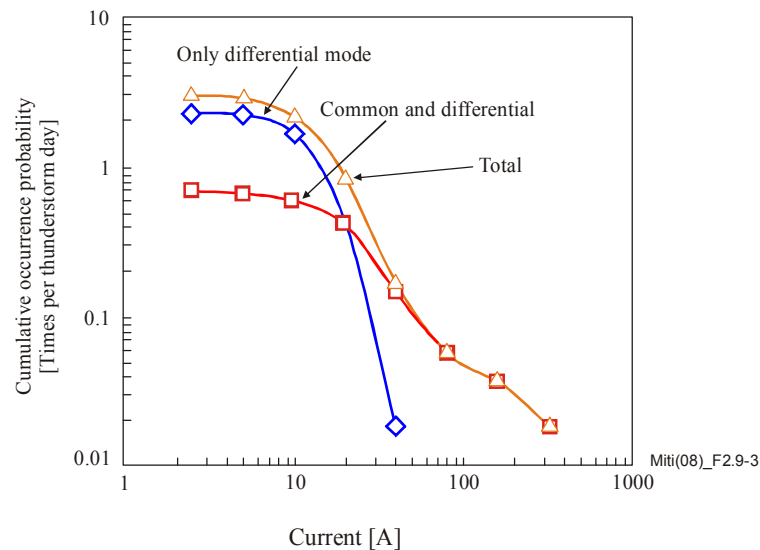
Figure 2.9-3 – Cumulative occurrence probability for differential mode current

The lightning surge currents in common mode and differential mode were observed in ten systems where failure often occurred. Two types of waveform and occurrence probability were obtained. The data are summarized in Table 2.9-1 and Figure 2.9-3. Malfunctions occurred with both waveforms. The peak current values were about 30 and 300 A, respectively.

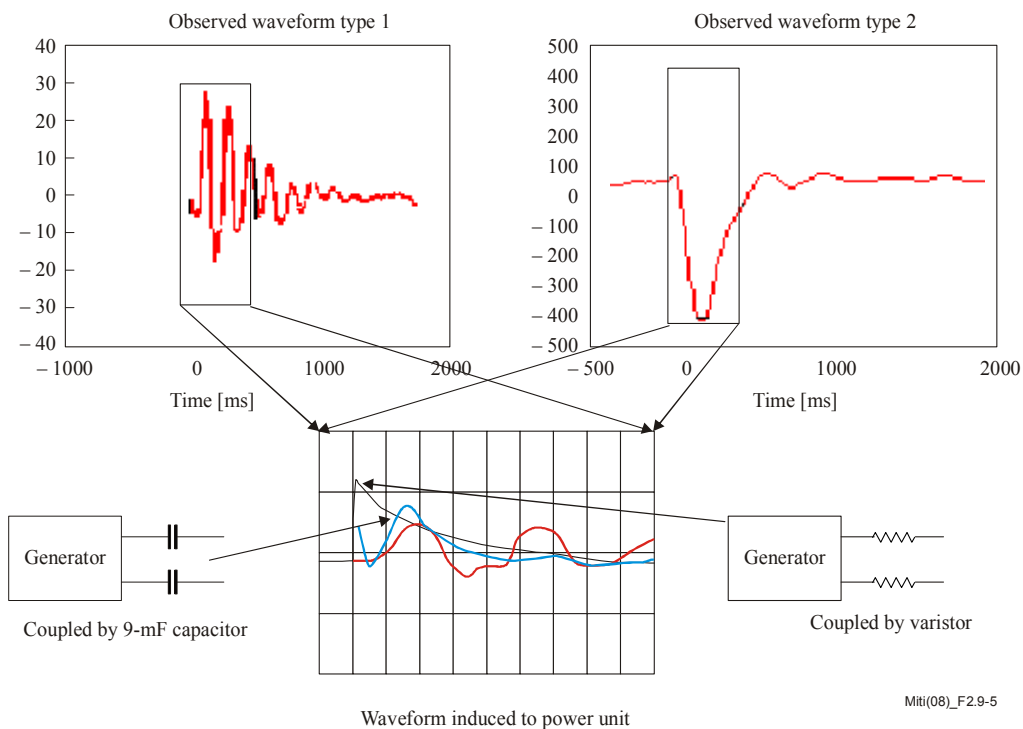
Figure 2.9-5 – Waveform difference by coupling methods

Noise immunity and lightning surge were tested. Malfunction did not occur in the immunity test. Also, several lightning surge generators (e.g., 10/700 ITU-T and 1.2/50 combination) and coupling/decoupling methods were tested (Figure 2.9-4). It was necessary to test the coupling and decoupling units to confirm the induced waveform and current value, which depended on them (Figure 2.9-5). The results are shown in Figure 2.9-6.
