Measurement/Searching techniques/Experiment

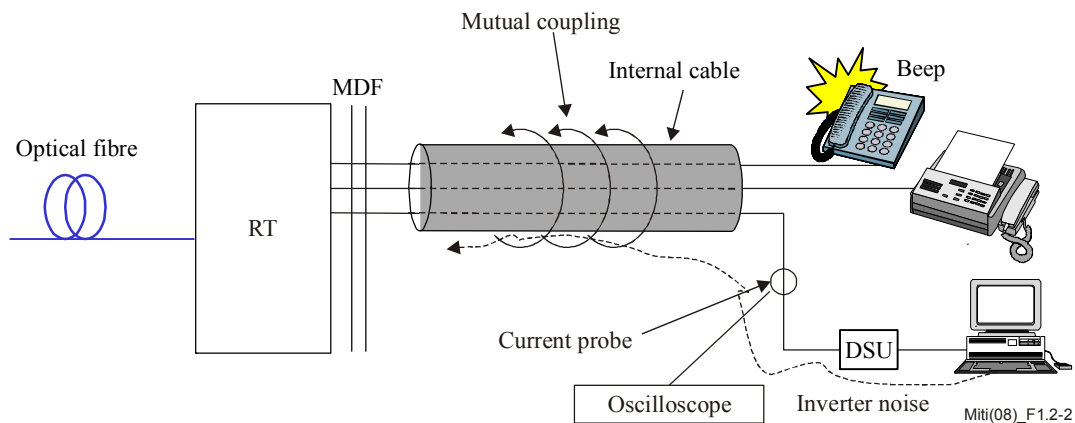
Figure 1.2-2 – Measurement of noise current on lines

To identify the noise sources, electric current wave shapes were measured using a current probe as shown in Figure 1.2-2. First of all, the current in the line connected to the telephone where the acoustic noise problems occurred was measured. The current level was not high but could cause malfunction of the telephone. However, the wave shape had little relation with the telephone because inverter noise spectrum was included in the wave shape. Next, the current on the line connected to the DSU was measured (see Figure 1.2-3). The current level was $240 \text{ mA}_{\text{p-p}}$, which is not a low level. As a result of the investigations, it was confirmed that the electric current noise originated at the DSU power source because the noise disappeared when the DSU was turned off. The noise current from the DSU travelled over the internal cable. In the cable, mutual coupling phenomena occurred. The noise current from the DSU induced noise current on the line connected to the telephone. The current caused malfunction of the telephone and the noise was detected in the telephone.
