Mitigation method/Results/Conclusion

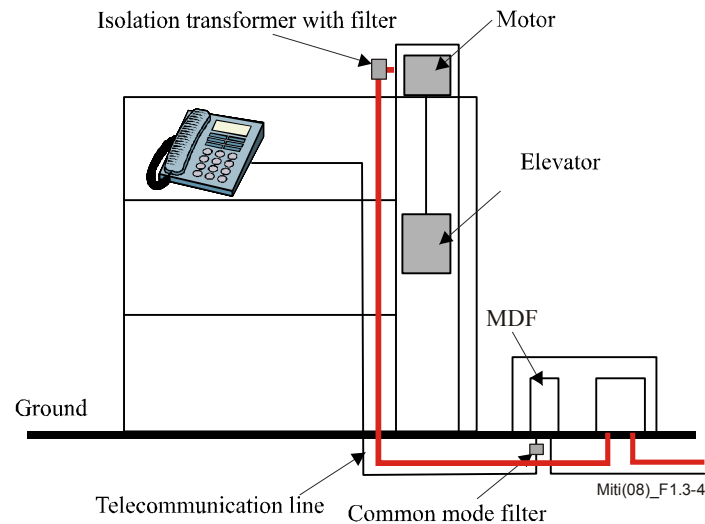
Figure 1.3-4 – Applied mitigation using common mode filter

The acoustic problem originated in the mutual coupling of the switching noise of the motor. To solve this problem, it was decided to apply a common mode filter to the telecommunication line and an isolation transformer to the mains power line (see Figure 1.3-4). The isolation transformer with a filter was attached to the mains power line, and the filter was located as near as possible to the motor, so as to prevent the switching noise from travelling along the cable. The common mode filter at the MDF was attached to the telecommunication line.
