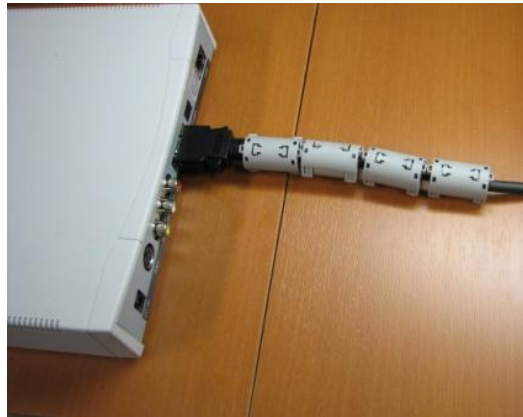
Figure 1.13-4 – Mitigation by ferrite cores

As this problem was caused by the conducted disturbance wave from the IP-STB, four ferrite cores (Attenuation > 20 dB @ 10-100 MHz) were installed on the component video cable as shown in Figure 1.13-4. Figure 1.13-5 shows the variation of the D/U ratio after the installation of those ferrite cores. As the figure shows, the D/U ratio rose to about 45 dB, and this problem was solved.
