Mitigation method/Results/Conclusion

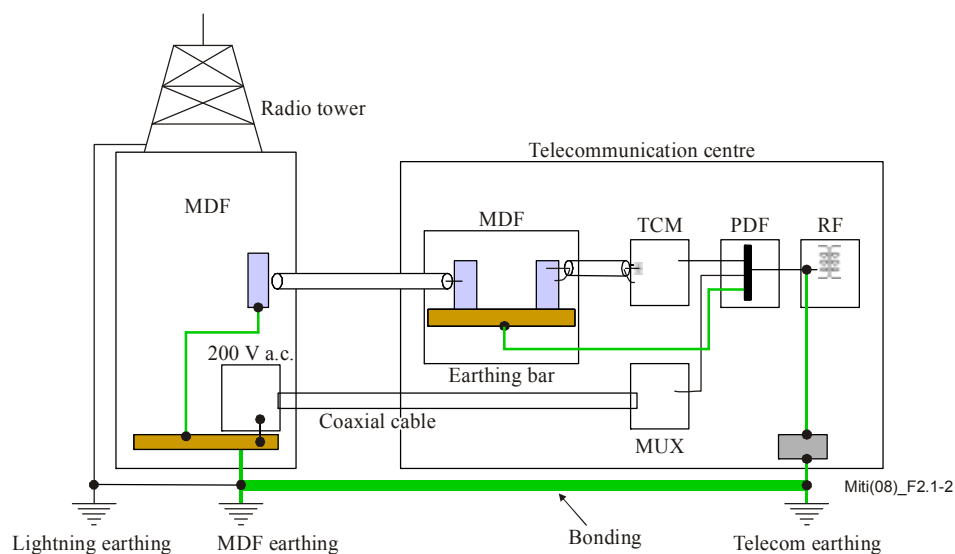
Figure 2.1-2 – Mitigation configuration

After investigations, it was confirmed that the transmission equipment, and the MUX could be damaged by surge current flowing from the building with the antenna tower, due to the electric potential difference between the building and telecommunication centre. For this telecommunication installation, a bonding network reduced the potential difference between the telecom centre and the other building. MDF earthing was also connected to the earth, as shown in Figure 2.1-2.

More detailed consideration should be given to connecting earthing networks when dealing with power systems of IT installations. The earthing resistance of IT systems is too high to absorb power fault current. If the earthing networks of several buildings are connected to each other, the total earthing resistance is lower than the original individual one. Therefore, national regulations or the relative Recommendations should be referred to.
