## Mitigation method/Results/Conclusion

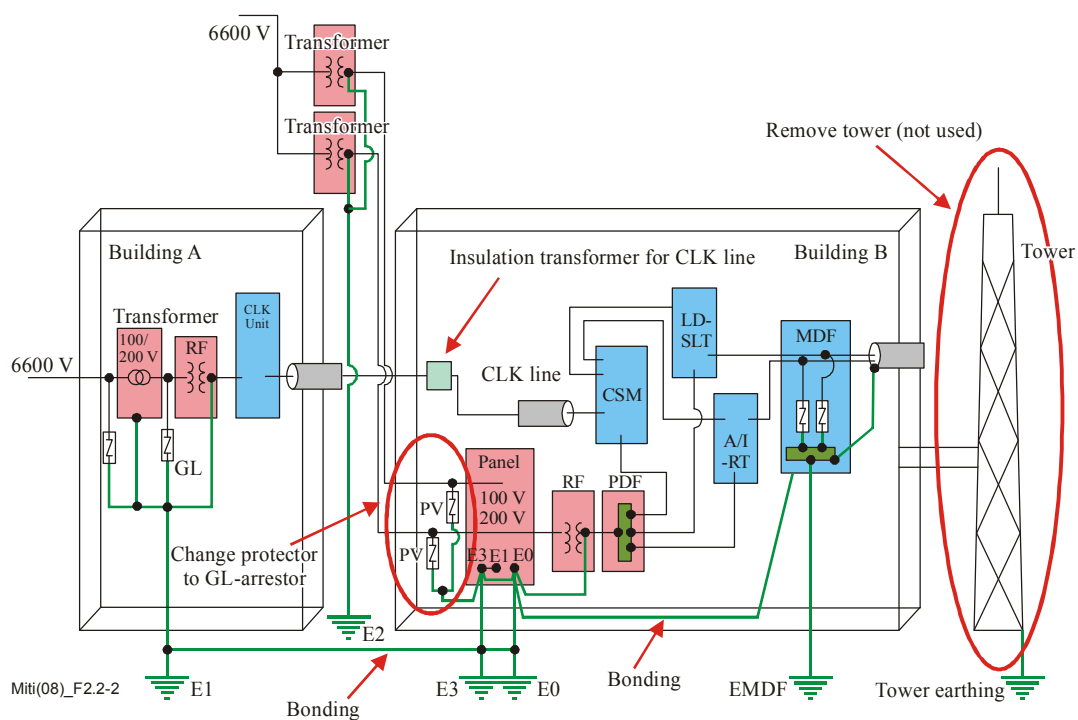
**Figure 2.2-2 – Mitigation configuration**

The investigation revealed that this damage was due to the potential difference between the two buildings. Therefore, bonding of earthing systems should be used to reduce the potential difference, although the residual voltage difference might still remain. Therefore, it was recommended to insert an isolation transformer in the clock line, as shown in Figure 2.2-2. Additional mitigation measures were taken: the antenna tower that is not in use was removed; and to achieve an equipotential earthing system, earthings E0, E1, E3, and EMDF are connected to each other.

More detailed consideration should be given to connecting earthing networks when dealing with power systems of IT or other systems. The earthing resistance of IT systems is too high to absorb power fault current. If the earthing networks of several buildings are connected to each other, the total earthing resistance is lower than the original individual one. Therefore, national regulations or the relative Recommendations should be referred to.
