Mitigation method/Results/Conclusion

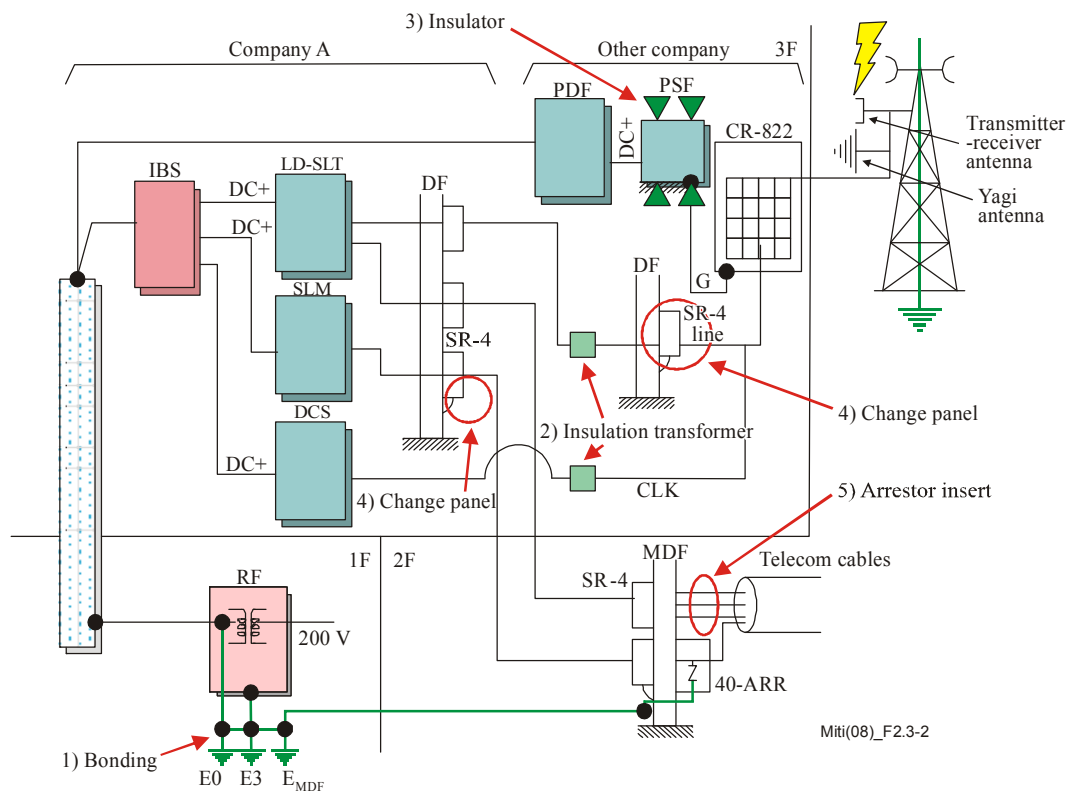
Figure 2.3-2 – Mitigation configuration

It was estimated that direct lightning hit the antenna tower, and the surge current entered the telecom centre through the coaxial cables and the building structures, flowing into the radio equipment. The current entered the LD-SLT through the radio equipment, the SLM through the building structure or floor, and the DCS through the radio equipment.

To prevent these damages from occurring again, it was required to do the following, as shown in Figure 2.3-2:

- Bonding earthing networks.
- Insert insulation transformer in CLK line.
- Insert insulation bushing to isolate the equipment from building structures.
- Change the cable panel with high insulation resistibility.

More detailed consideration should be given to connecting earthing networks when dealing with power systems of IT or other systems. The earthing resistance of IT systems is too high to absorb power fault current. If the earthing networks of several buildings are connected to each other, the total earthing resistance is lower than the original individual one. Therefore, national regulations or the relative Recommendations should be referred to.
