<b>Case study #</b>	2.4
<b>Title</b>	Damage on ISM (I-Interface Subscriber Module)
<b>Type of trouble</b>	Damage.
<b>Source of trouble</b>	Lightning.
<b>System affected</b>	Transmission equipment.
<b>Location</b>	Telecommunication centre.
<b>Keywords</b>	Damage, lightning surge.
<b>Version date</b>	2004-01-01

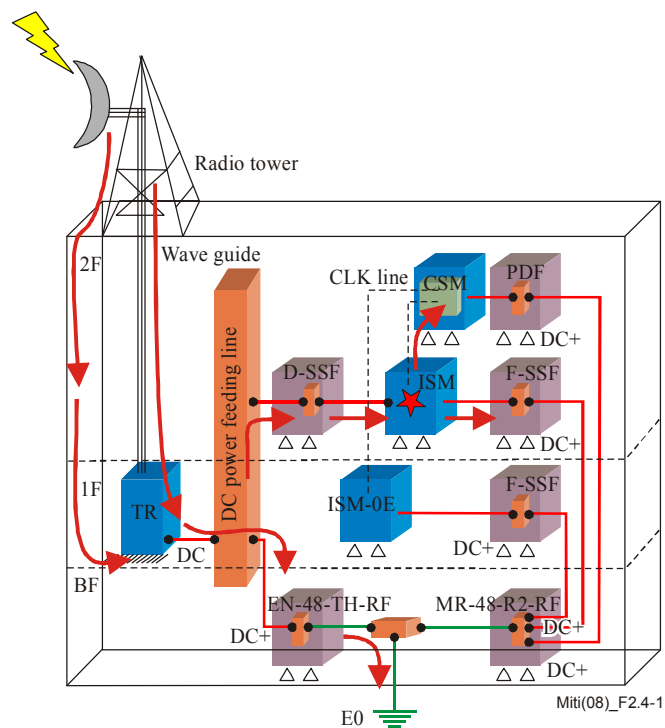
**Figure 2.4-1 – System configuration**

A system configuration and an estimated current flow are shown in Figure 2.4-1. At a lightning stroke, a switching equipment ISM (I-interface subscriber module) on the second floor, was damaged and its operation was halted. An ISM equipment located on the first floor was not damaged. No other equipment, aside from the ISM was damaged, and there were no error messages except those of the ISM equipment. The ISM on the second floor was connected to two power equipments, D-SSF and F-SSF.

The main power equipment is MR-48 on the ground floor, and the potential reference is a dc+ point in the MR-48. The current flowing through the ISM on the second floor followed a large loop, as shown in Figure 2.4-1. It is assumed that the equipment is easily affected by lightning.
