Mitigation method/Results/Conclusion

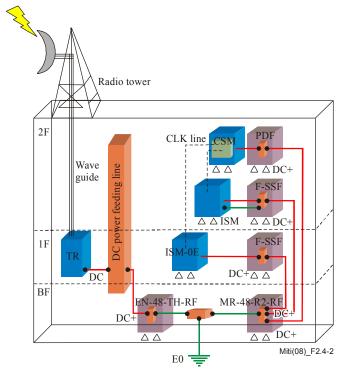
Figure 2.4-2 – Mitigation configuration

At this installation, the lightning struck the antenna tower; the surge current flowed into E0 earthing through the wave guide and building structures, and the DC power feeding line. The potential of E0 and also of the DC power feeding lines rose. The surge current penetrated ISM and flowed into E0, and then the ISM packages were damaged. To solve this problem, it was required to change the feeding routes as shown in Figure 2.4-2.
