Case study #	2.5
Title	Damage of 2-Mbit/s HDSL system
Type of trouble	Damage.
Source of trouble	Mistakes in bonding.
System affected	2-Mbit/s HDSL system using copper pair cable.
Location	Telecom centre.
Keywords	Damage, short circuit, mistakes in bonding.
Version date	2004-01-01

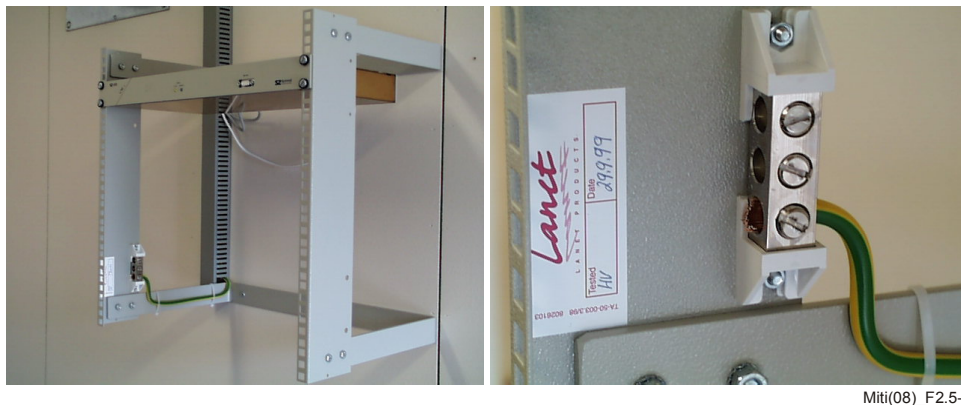
Miti(08)_F2.5-1

Tests revealed that the origin of the damages was 50-Hz induction or earth potential rise voltages rather than lightning transients. The manufacturer decided to re-design the protection inside of the equipment to fulfil enhanced level power induction and earth potential rise requirements of Rec. ITU-T K.20. Systems having this new design were installed for pilot use in spring 2000 and they worked properly all of summer 2000. However, too many systems of the original type were again damaged in 2000. Maybe there were cases where the instruction to change to local power supply was followed. A field survey also revealed another reason: improper earthing of the equipment. A practical example is shown in Figure 2.5-1.

Figure 2.5-1 – System configuration (An example of mistakes in bonding)
