<b>Case study #</b>	2.7
<b>Title</b>	Lightning damage to a telephone
<b>Type of trouble</b>	Damage.
<b>Source of trouble</b>	Lightning.
<b>System affected</b>	Customer equipment.
<b>Location</b>	Customer premises.
<b>Keywords</b>	Damage, lightning surge, inherent resistibility, GDT
<b>Version date</b>	2004-01-01

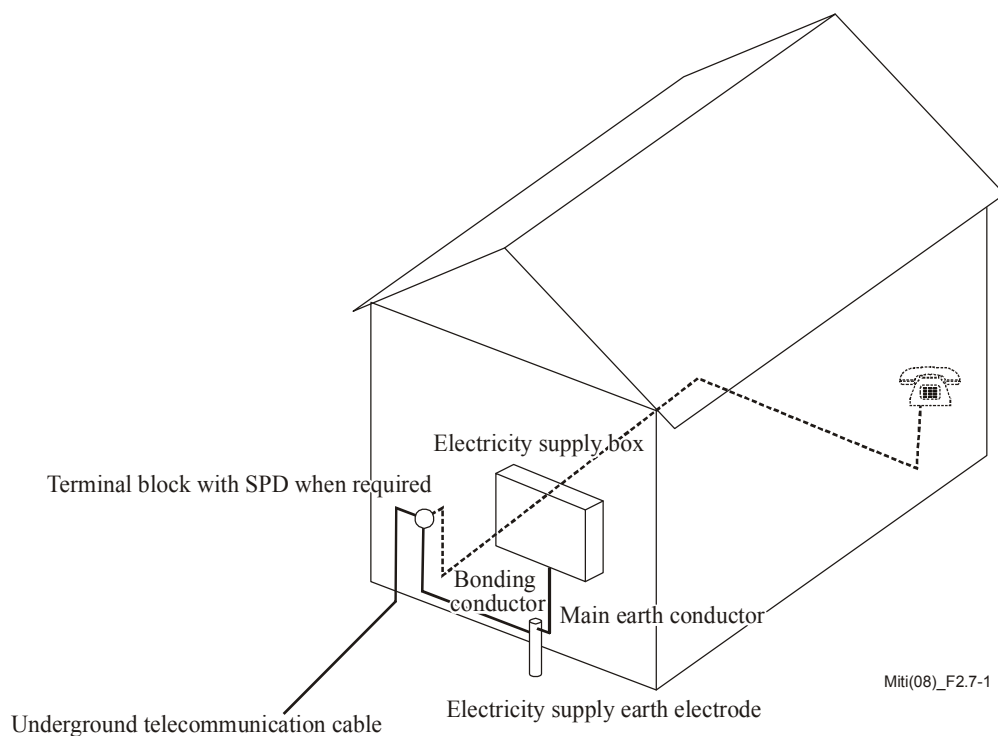
**Figure 2.7-1 – System configuration**

The problem equipment is a telephone powered from the telecommunication line, in a customer premises. An integrated circuit (IC) in the phone was being physically damaged (impulse type damage). It was assumed that lightning was causing this damage and loss of function. Of the 50 customer premises investigated, half had primary protection and the other half did not. Most customers remembered a very close lightning strike.
