### Identifying failed components

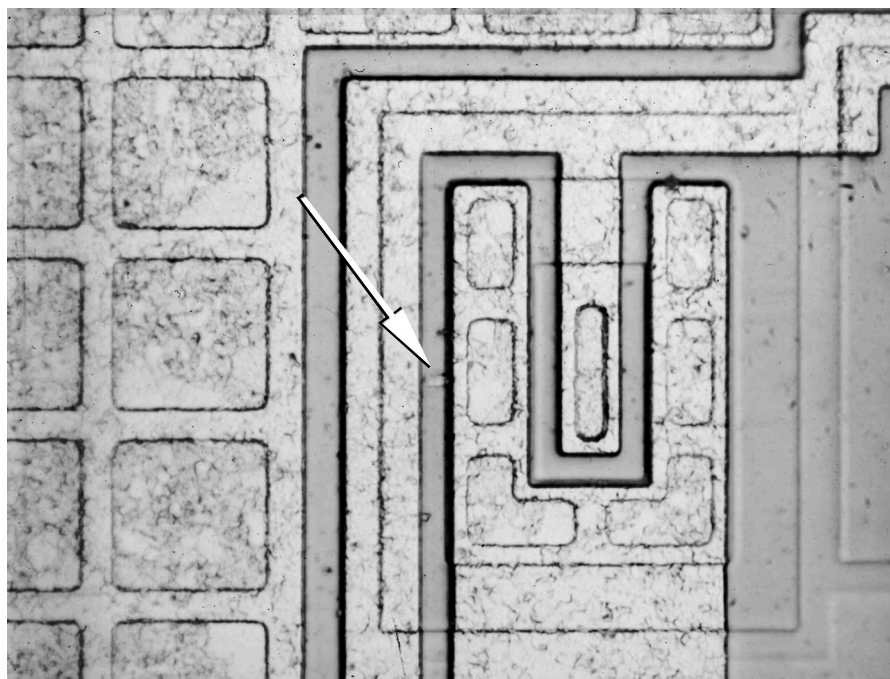
Miti(08)\_F2.7-2

The first part of the investigation was to identify the damaged components using normal service techniques. The component most damaged was a transmission IC. The plastic coating on top of the IC was then removed using chemical etching to expose the die. The die was then inspected using an optical microscope and photographed. Typical field damage can be seen in Figure 2.7-2.

**Figure 2.7-2 – Damage to the transmission IC by lightning strikes**

This damage is due to a breakdown between a conductor track and a ground as a result of an impulse overvoltage.

The next experiment was to check if high voltages (up to 100 kV) applied longitudinally could cause high charging currents and damage the IC due to the capacitance of the phone to earth. The charging currents did not cause damage but when one side of the line discharged to earth, the damage was replicated.
