Case study #	2.8
Title	Earth wire voltage drop in telecommunication centre
Type of trouble	Damage.
Source of trouble	Lightning.
System affected	Transmission equipment.
Location	Telecommunication centre.
Keywords	Damage, lightning surge.
Version date	2004-01-01

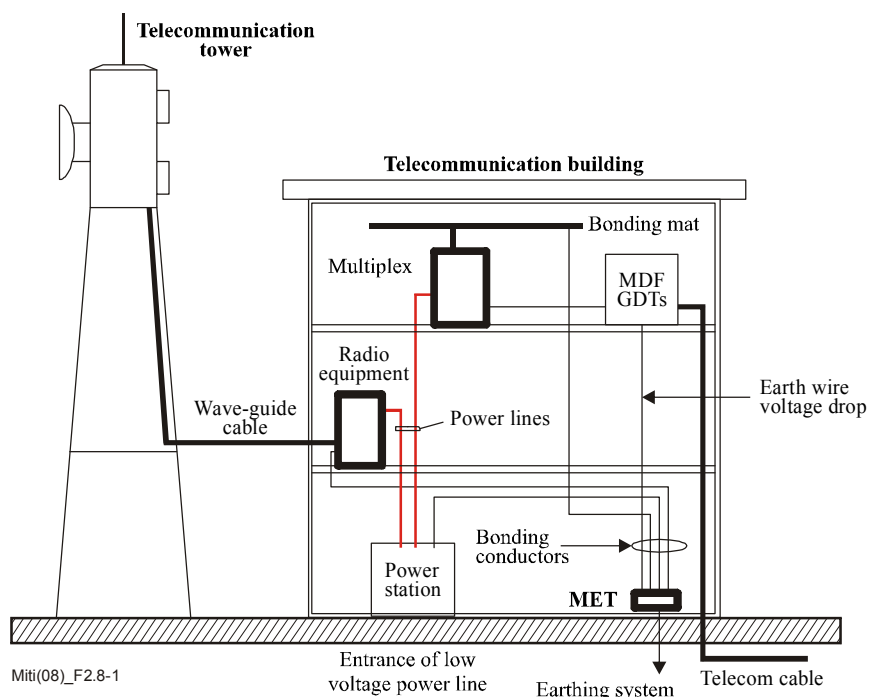
Figure 2.8-1 – Radio station

Located on the top of a mountain, the radio station is composed of a 40-m high telecommunication tower and an adjacent 2-floor building (Figure 2.8-1). The antennas on the tower are connected to the radio equipment inside the building by wave-guide cables.
