Case study #	2.9
Title	Malfunction of circuit breaker due to lightning surges
Type of trouble	Abnormal operation.
Source of trouble	Lightning.
System affected	Access system.
Location	Outdoors.
Keywords	Safety, immunity, lightning, power transmission line, circuit breaker, MOV.
Version date	2004-01-01

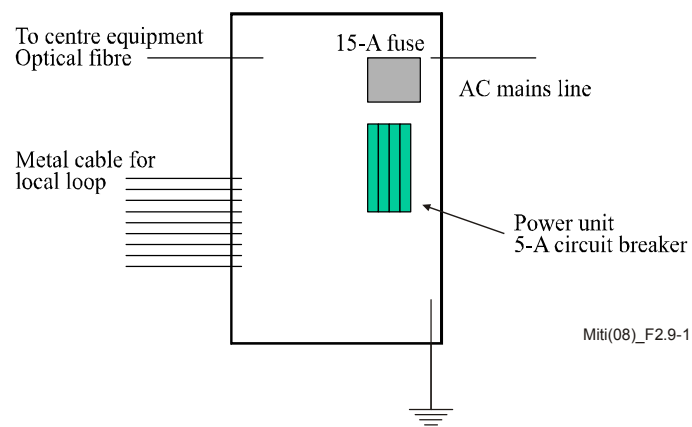
Figure 2.9-1 – Access network system

The circuit breakers in the power units of an access network system located outdoors malfunctioned due to lightning. The access network system had an optical fibre cable, which was connected to centre equipment, a metallic subscriber cable, and an AC mains line (Figure 2.9-1). The system had four power units. Each unit had a circuit breaker, with a capacitance of 5 A at the AC mains frequency. Figure 2.9-2 shows the system's protection circuits. The power units are produced by two manufacturers. Their circuits were almost the same, but they had different malfunction occurrence probabilities.
