## Mitigation method

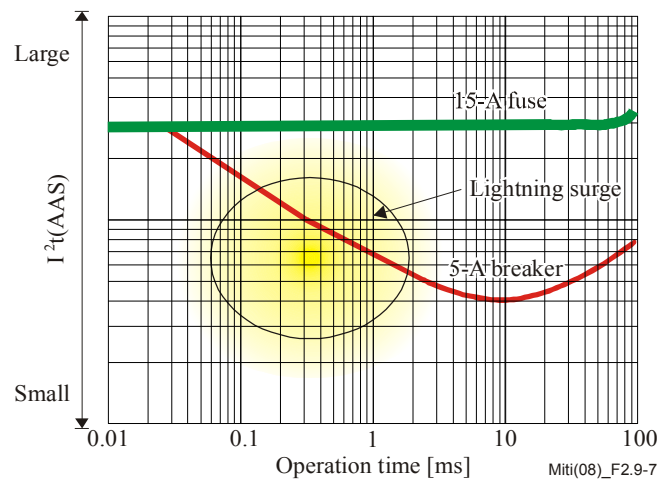
**Figure 2.9-7 – Operation time and energy**

This malfunction was caused by two mechanisms. One was the lightning surge current flowing into the circuit breaker when MOV3 operated. In the field, the 15-A fuse did not break often, but the breaker did trip. The relationship between the lightning and operation time is shown in Figure 2.9-7. A new circuit breaker, whose characteristics at the AC mains frequency were the same, was developed and the response characteristics to lightning were improved.

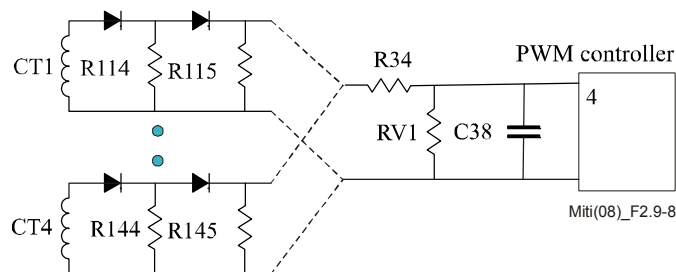
**Figure 2.9-8 – PWM controller and filter**

The second mechanism was the malfunction of the pulse width modulator (PWM) controller, which has an overcurrent latch circuit consisting of a current transformer and filter circuits, as shown in Figure 2.9-8. The filter circuits (e.g., R114, R115, R34, RV1, C38) were from different manufacturers. In particular, R114 and R144 determine the sensitivity of CT1 and CT4, so their resistances were set smaller, and this improved the immunity level against lightning surges.
