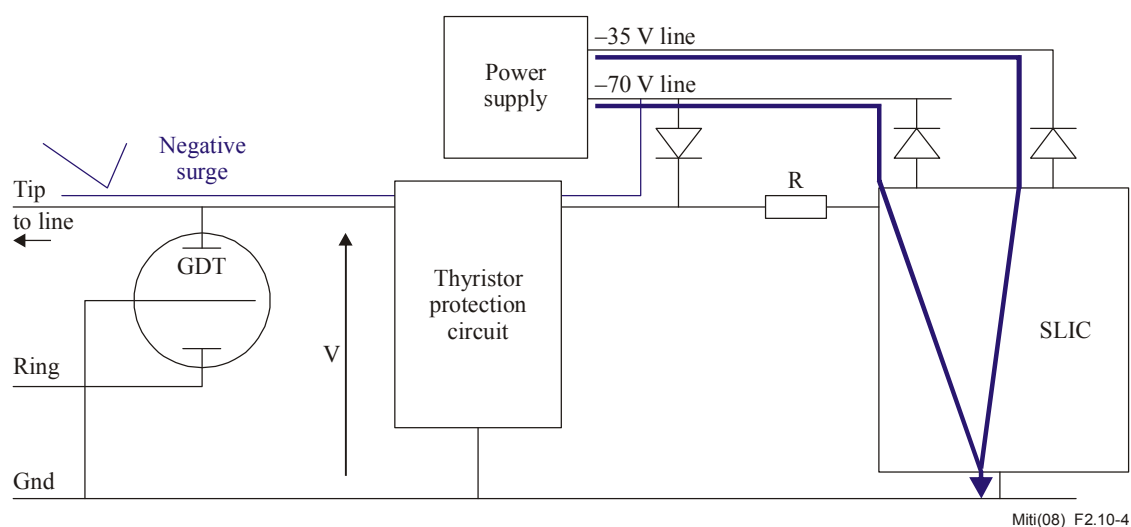
Figure 2.10-4 – Simple circuit showing path of surge on tip side of line

The failure appears to be caused by a negative surge entering under the firing voltage of the thyristor protection circuit (± 190 V) and causing the -70 V and the -35 V rails to become more negative by the current entering the power supply via the diode which clamps the incoming line to the -70 V supply rail. When the -70 V rail is surged to approximately -100 V and the -35 V rail is surged to approximately -45 V, the SLIC latches up and the current is conducted from the -70 V and -35 V rails to ground, see Figure 2.10-4, which shows the current path through the thyristor protection circuit and the diode to -70 V, and the current from the -70 V and -35 V rails through the SLIC. It is the power supply current that damages the two diodes which connect from the -35 V and -70 V supply lines to the SLIC circuit (based on the fact that the diode which clamps the incoming line to the -70 V supply rail is not damaged).

The diode which clamps the incoming line to the -70 V supply rail was probably added to prevent the SLIC line inputs exceeding -70 V. However, adding this diode has resulted in rendering the thyristor protection circuit redundant and causing the SLIC to have its -70 V and -35 V ratings exceeded.

Magnitude of Voltage V less than required to operate either the thyristor protection circuit or the GDT. Only part of the Tip side of the circuit is shown for simplicity.
