Mitigation measures for telecommunication installations

Part 2: Case Studies

ITU-T

2008

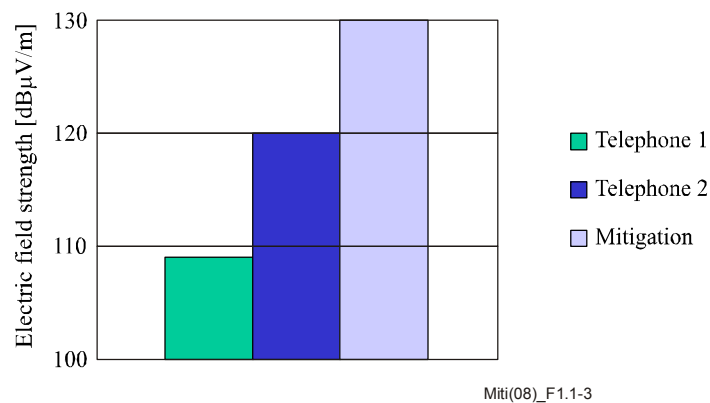
Figure 1.1-3 – Immunity levels of the telephone sets

The immunity level of the telephone sets are shown in Figure 1.1-3. The immunity level of Telephone 1 was less than 110 dB μ V/m, compared to the electric field at the real location. After testing, it was found that noise can be induced through the telecom port and the inner port connecting the telephone and the handset cord.

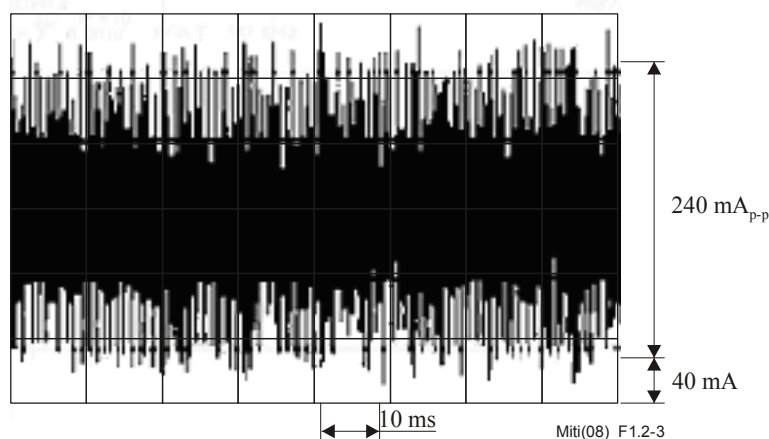
Figure 1.2-3 – Current wave shape in the line connected to the DSU

To identify the noise sources, electric current wave shapes were measured using a current probe as shown in Figure 1.2-2. First of all, the current in the line connected to the telephone where the acoustic noise problems occurred was measured. The current level was not high but could cause malfunction of the telephone. However, the wave shape had little relation with the telephone because inverter noise spectrum was included in the wave shape. Next, the current on the line connected to the DSU was measured (see Figure 1.2-3). The current level was $240 \text{ mA}_{\text{p-p}}$, which is not a low level. As a result of the investigations, it was confirmed that the electric current noise originated at the DSU power source because the noise disappeared when the DSU was turned off. The noise current from the DSU travelled over the internal cable. In the cable, mutual coupling phenomena occurred. The noise current from the DSU induced noise current on the line connected to the telephone. The current caused malfunction of the telephone and the noise was detected in the telephone.

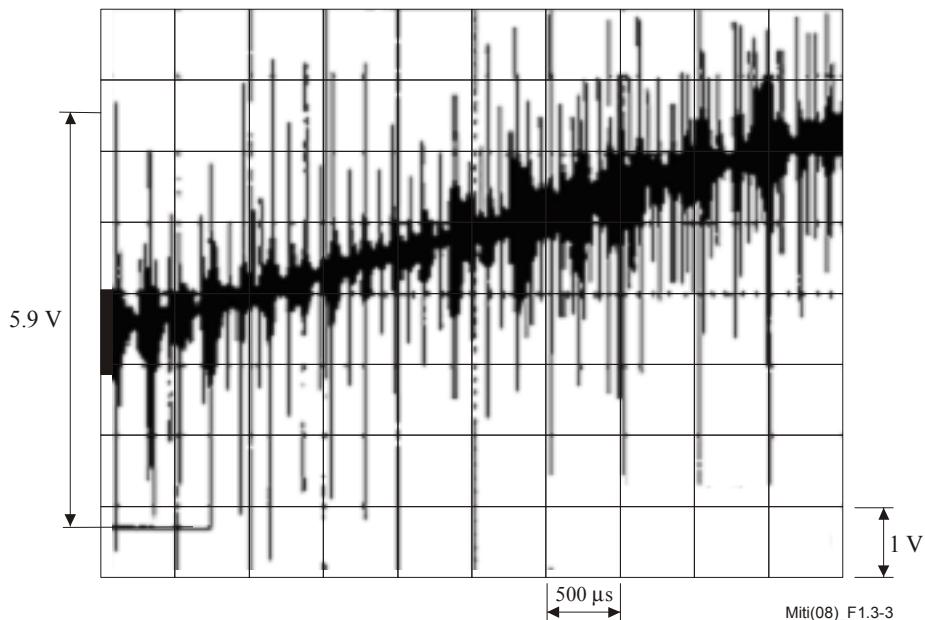
Figure 1.3-3 – Current wave shape on the line connected to the telephone

To solve this acoustic problem, the current in the telecommunication line was measured (Figure 1.3-2). The common mode current wave shape is shown in Figure 1.3-3. A typical period 200-300 μs periodic characteristic can be seen in the figure. Its major frequency is about 5 kHz and it was estimated that the noise source must be a switching power source. The investigations showed that the power mains cable was wired parallel to the telecommunication line, and that the telecommunication line was connected to the main distribution frame (MDF) room, where the mains power transformer was located.

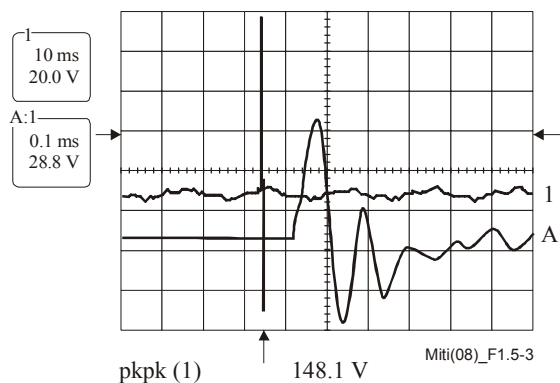
Figure 1.5-3 – Voltage transient on the copper – cable

Through the screen that was earthed at both sides (screen resistance 13.5Ω), the optical fibre was the source for the induction into the parallel copper cable. The metallic foil of the 10-pair cable was earthed on only one side, connected to the earth of the distribution point.

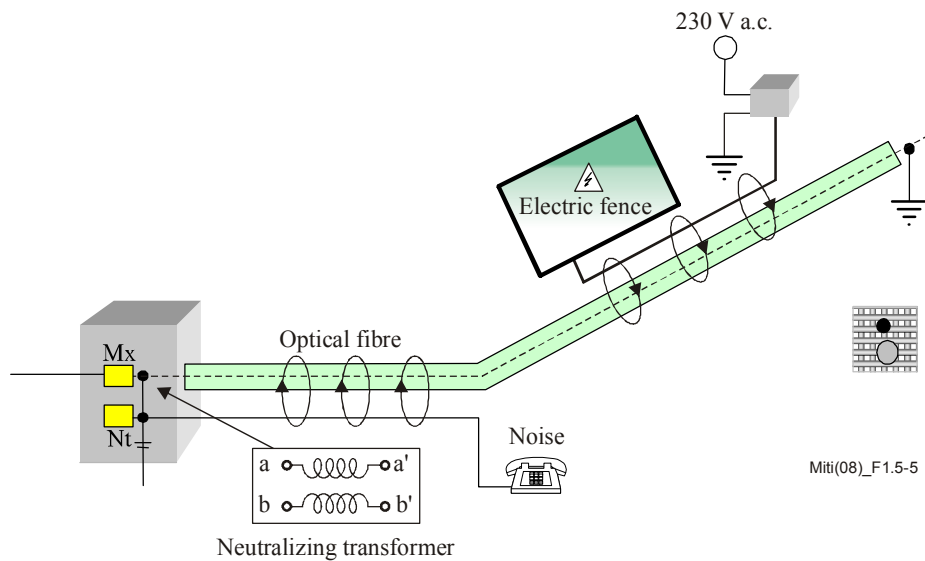
Figure 1.5-5 – Mitigation method

The buried power supply cable of the fence was poorly isolated, i.e., the connecting points were not isolated. Because of the disturbances, the following solution was found, in agreement with the owner of the electric fence: increase the distance between the power supply cable of the electric fence and the optical fibre cable, and properly isolate the connectors.

First, the metallic foil of the 10-pair copper cable was connected to the main earthing terminal at the customer site. As a result, the transient voltages were reduced to 1/6 of the value that had before mitigation (Figure 1.5-6). The remaining voltage, which was about 23 Vp-p, still caused some clicking noise. To solve this problem, it was decided to install a neutralizing transformer at the distribution point. This led to a decrease of about 3 Vp-p, making the disturbance vanish.

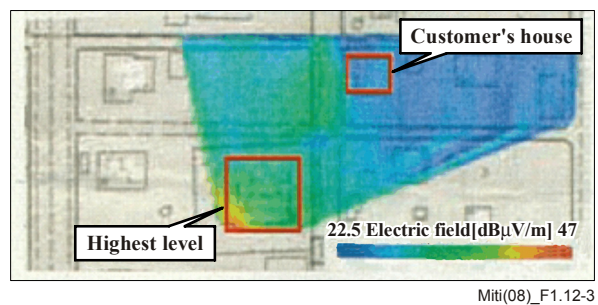
Figure 1.12-3 – E-field distribution near the customer

Figure 1.12-3 shows the results of measuring the electric field distribution around this location. The results indicate that the highest electric field strength was observed near the building and that the measured level tended to decrease as the distance from the building increased.

As a result, it was confirmed that the disturbance came from the building in front of the customer's house. The source of this interference was investigated and it was found that the interference signal radiated from transmission equipment in the building.

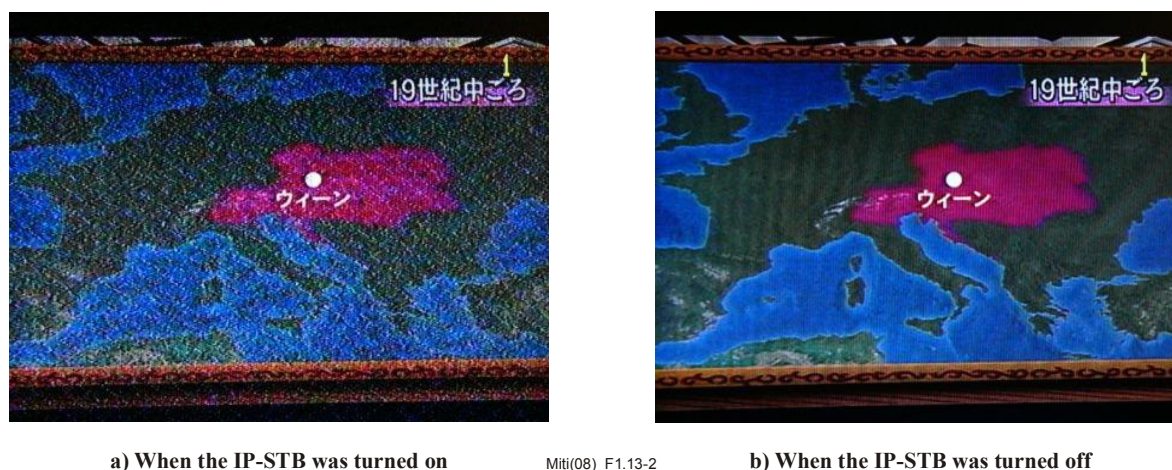
Figure 1.13-2 – Examples of TV screen: Video noise occurred when the IP-STB was turned on or off

As shown in Figure 1.13-2, video noise occurred in a channel (91.25 MHz) of analogue TV broadcasting when the IP-STB was turned on. This problem was solved when the IP-STB was turned off or when the component video cable was disconnected. The trouble source was considered to be the conducted disturbance wave from the IP-STB.

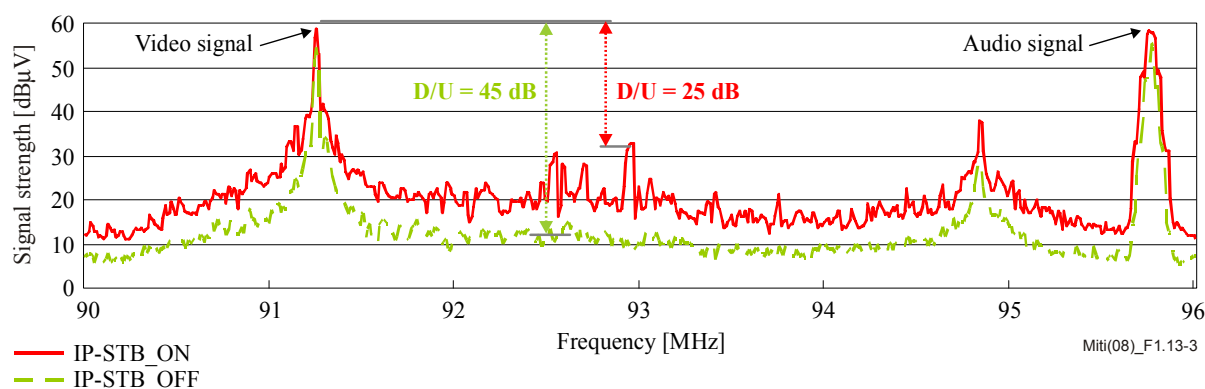
Figure 1.13-3 – Measured results of received signal spectrum

The TV broadcasting signal and conducted disturbance wave were measured at the measurement point shown in Figure 1.13-1. Figure 1.13-3 shows the measured spectrum of the received signals. The desired signal to undesired signal (D/U) ratio was 25 dB when the IP-STB was turned on, and 45 dB when the IP-STB was turned off. As the D/U ratio of 40 dB is required for analogue TV broadcasting, this video noise on the TV picture was caused because the required D/U ratio was not being achieved.

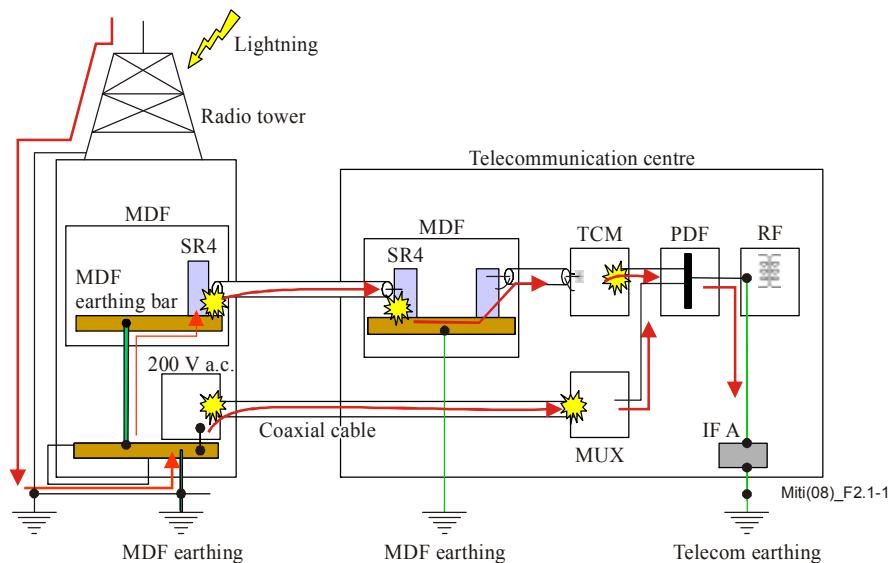
Figure 2.1-1 – System configuration

The system configuration for a lightning surge trouble case is shown in Figure 2.1-1. As depicted in the figure, a transmission equipment, a TCM (transmission communication module), was located in the telecommunication centre, and there was a building with an antenna tower next to the telecommunication centre. Coaxial cables were used between the two buildings to connect the transmission equipment with the radio equipment. The earthing of the telecommunication centre and the earthing of the building were not connected to each other. The main distribution frame (MDF) earthing was not connected to the telecommunication centre earthing, either.

As a result of the investigation, lightning surge strikes were detected at the radio antenna tower by visual inspection. Lightning surge current flowed through the tower, the earthing, power supply, MUX and TCM. It was considered that the surge current in the coaxial cables could damage the telecom equipment, TCM and MUX.

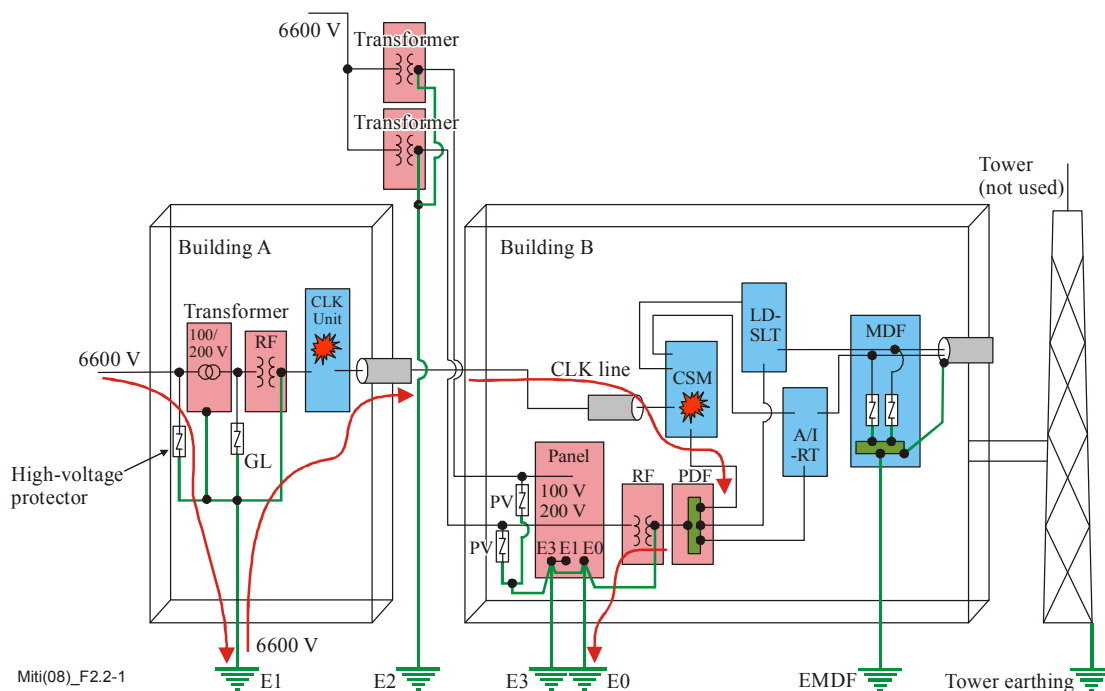
Figure 2.2-1 – System configuration and estimated surge current flows

The investigation determined that a lightning surge entered via the power mains of building A and that a power fault had occurred near the buildings. The surge current entered building A, flowing to its earthing. The increase in potential was caused by the lightning surge current. Buildings A and B were connected by the 64-kHz clock line; however, the earthing systems of the two buildings were independent from each other. Therefore, there was potential difference between a clock unit of the telecom equipment (CLK Unit), in Building A, and a clock interface of the CSM (Clock Supply Module) in Building B. As a result of surge current flows, the two equipments were damaged. It was estimated that the surge current went through the CSM to earthing E0.

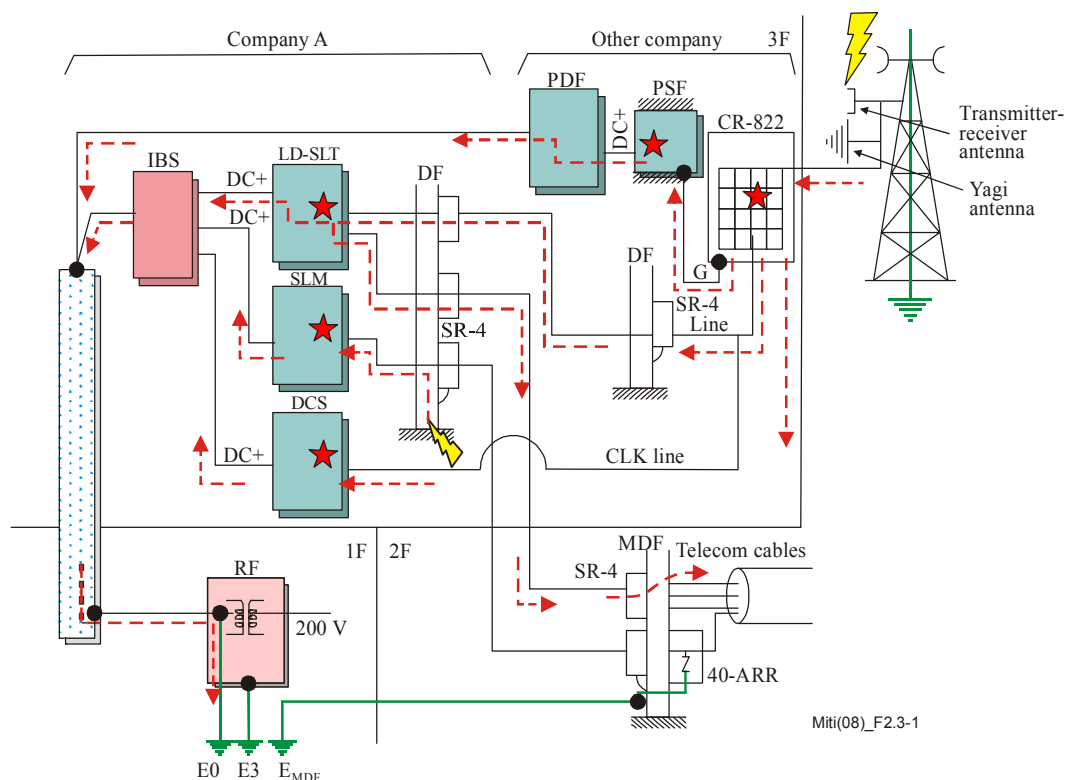
Figure 2.3-1 – A system configuration and an estimated surge current

Company A's telecommunication equipment is powered through the IBS, while the other company's equipment is powered through the PDF, where PDF and IBS are power distribution frames. The PDF and IBS are also connected to the RF located on the first floor. DCS is a clock-supplying equipment that provides the clock signal to the radio equipment CR-822. CR-822 has a telecom interface and is connected to the switching equipment LD-SLT through a DF (a distribution frame). At this telecom centre, LD-SLT, SLM, DCS, and PSF were damaged by lightning.

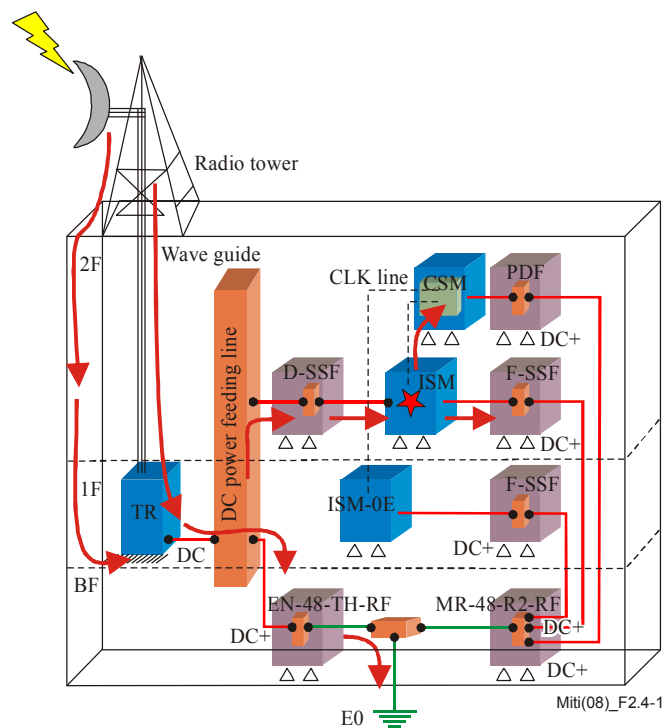
Figure 2.4-1 – System configuration

A system configuration and an estimated current flow are shown in Figure 2.4-1. At a lightning stroke, a switching equipment ISM (I-interface subscriber module) on the second floor, was damaged and its operation was halted. An ISM equipment located on the first floor was not damaged. No other equipment, aside from the ISM was damaged, and there were no error messages except those of the ISM equipment. The ISM on the second floor was connected to two power equipments, D-SSF and F-SSF.

The main power equipment is MR-48 on the ground floor, and the potential reference is a dc+ point in the MR-48. The current flowing through the ISM on the second floor followed a large loop, as shown in Figure 2.4-1. It is assumed that the equipment is easily affected by lightning.
