## Japan: what forces did the infrastructure have to face, and how did it stand up to the disaster?

### Lessons learned

By Hideaki Kimura  
NTT Access Network Service Systems Laboratories

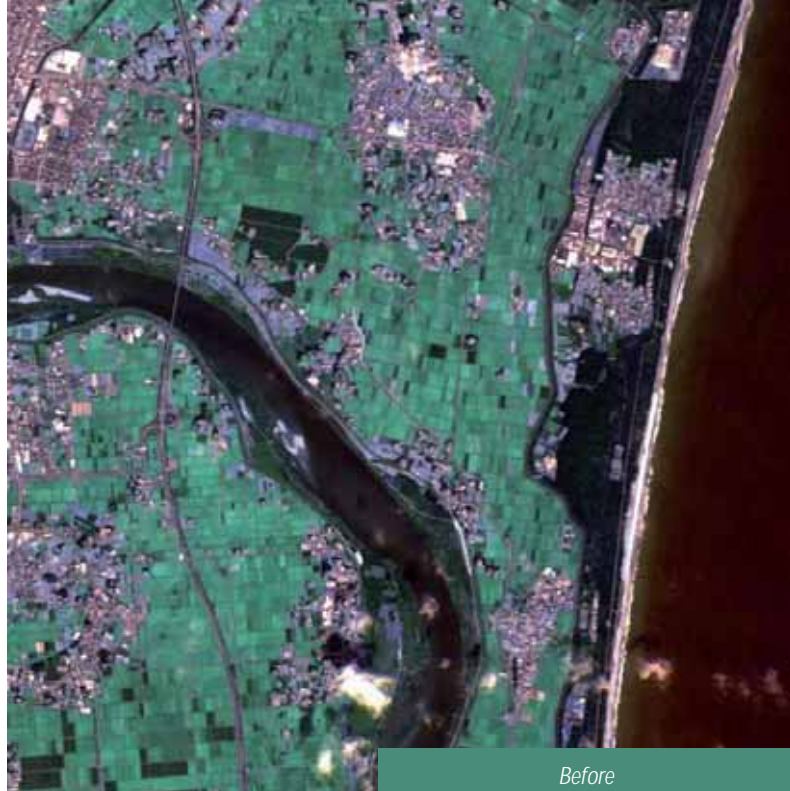
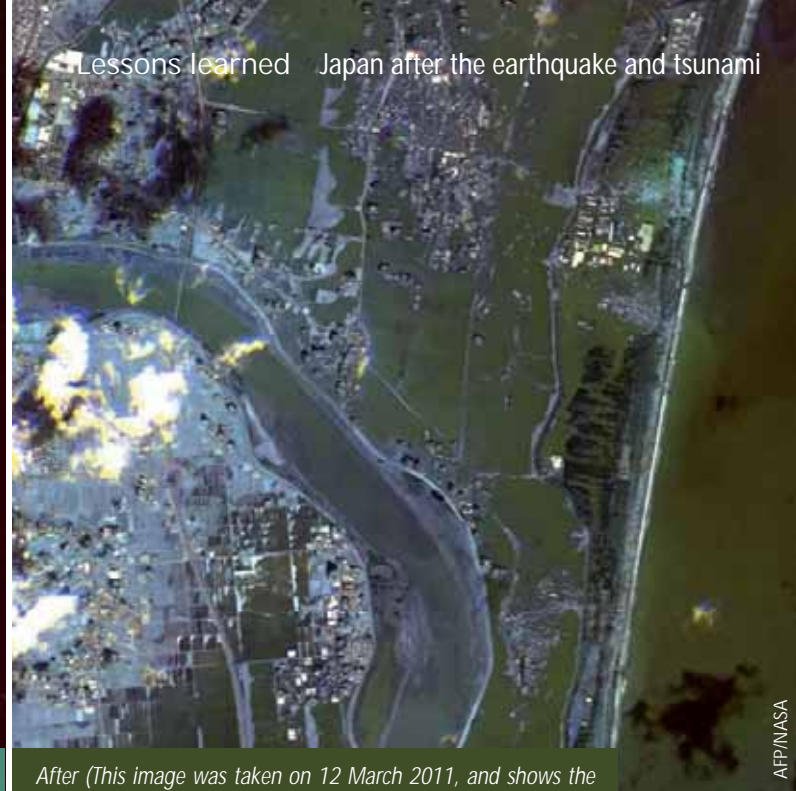
Before  
(5 September 2010)

After (This image was taken on 12 March 2011, and shows the effects of the tsunami on Japan's coastline and inland)

The two images shown above, from the United States National Aeronautics and Space Administration (NASA), were taken before and after the disaster. The image on the right was

taken on 12 March 2011, and shows how far the tsunami penetrated inland, having flooded Miyagi and Iwate. Photo 1 shows the damage caused by the ground liquidizing. This occurred in the Itako-shi, Ibaraki, area, and caused both subsidence and surfacing. Itako-shi, Ibaraki, suffered less damage than Miyagi and Iwate, but the effects were significant. Photo 2 shows damage caused by fill subsidence at the back of a bridge abutment, with two views of the broken bridge and a picture of the broken conduit. Photo 3 shows some of the other damage caused by the earthquake and tsunami. A widening of the gap between girders caused a bridge to fall. A dramatic landslide closed a road. Sometimes infrastructure was deformed rather than broken, for example the wavy road near the port or the undulating Hitachinaka Kaihin Railway.

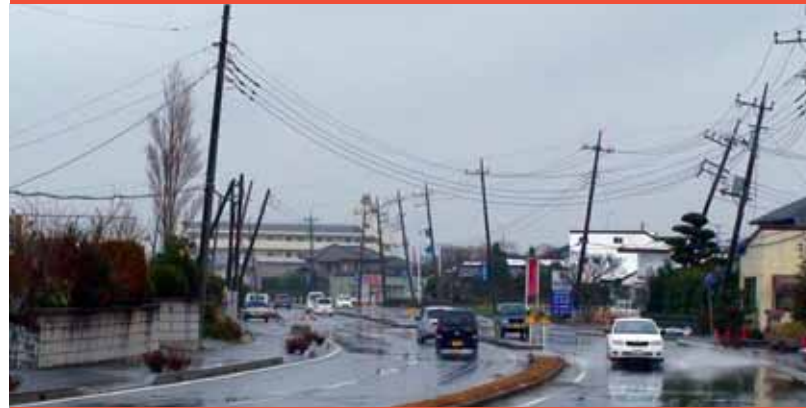
Photo 1 — Damage caused by land liquifying

*Inclination and subsidence of electrical pole*

To counteract equipment surfacing caused by ground liquefying, NTT constructs gravel drains around manholes. The effectiveness of this technology was confirmed by a study of the effects of the earthquake that occurred in the southern part of Hyogo in 1995.

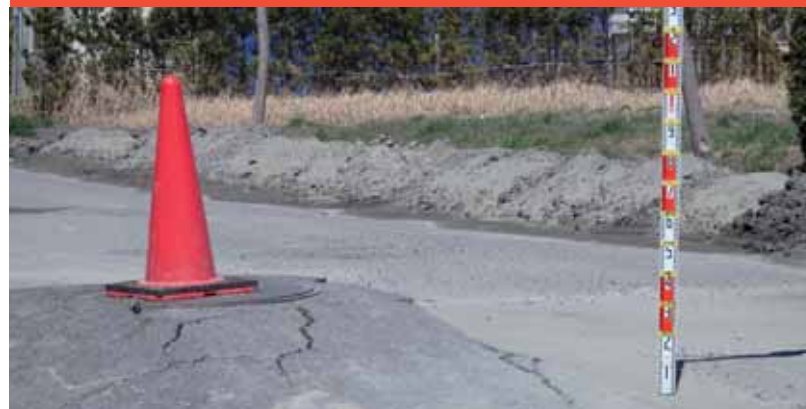
*Surfacing of NTT's manhole*

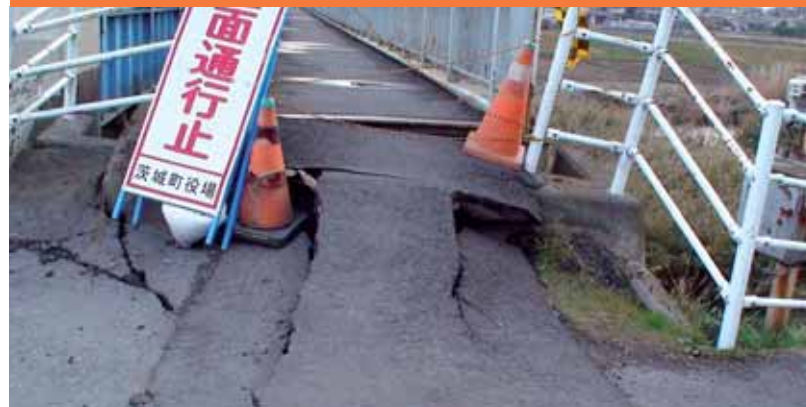
Photo 2 — Damage caused by subsidence

*Broken bridge*

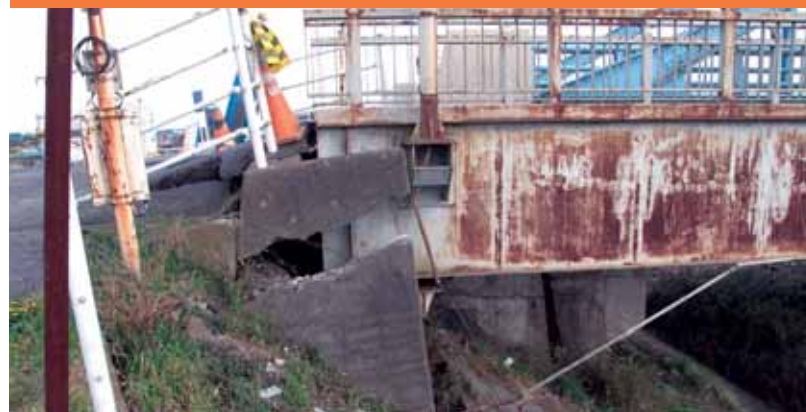
*Broken bridge (side view)*

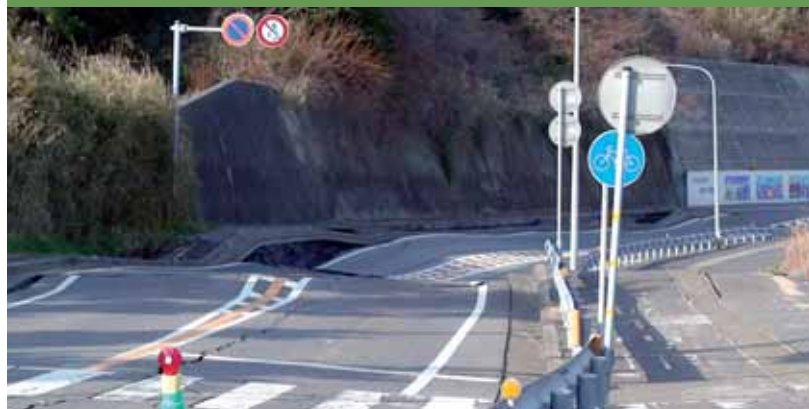
Photo 3 — Damage to road and railway

Deformed road

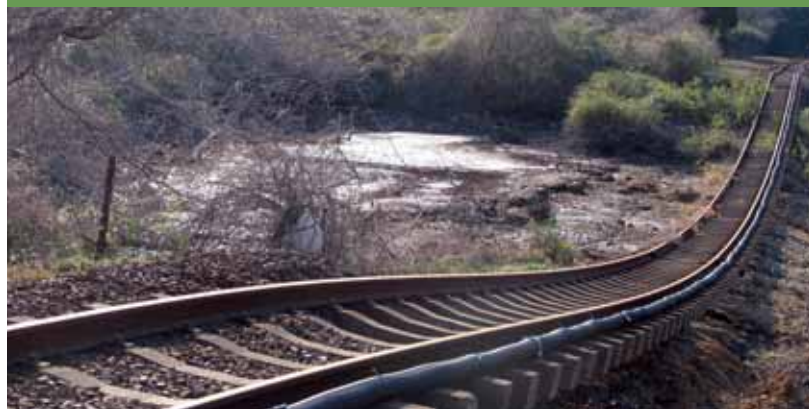
Deformed railway

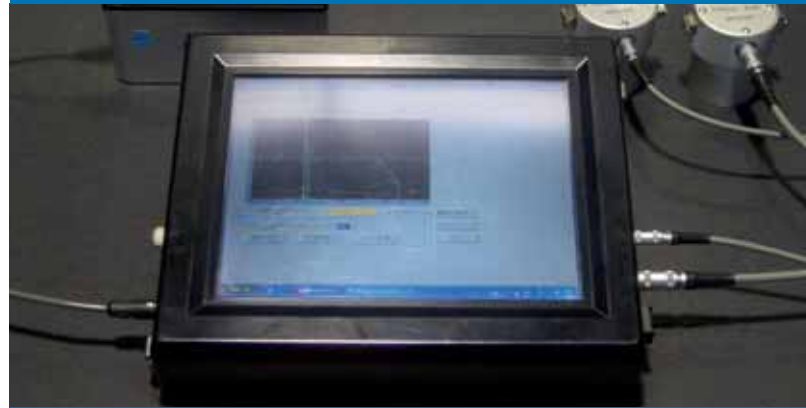
**Photo 5 — Non-destructive diagnostic technology to monitor concrete**

*Comprehensive supersonic wave method*

NTT is researching and developing “check and repair” technologies that can be used to monitor ageing equipment. Photo 5 shows two examples of non-destructive diagnosis technology, which use two different methods to assess the deterioration of concrete: the supersonic wave method; and the electromagnetic method. The supersonic wave method is a technology for assessing concrete thickness, the depth of cracks, the compressive strength of the material, and corrosion. The electromagnetic method is a technology for assessing the depth of cracks, along with deterioration factors such as salinity.

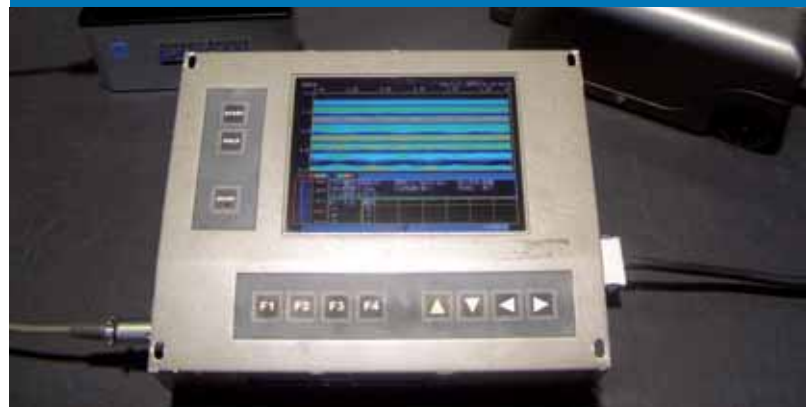
*Electromagnetic method*

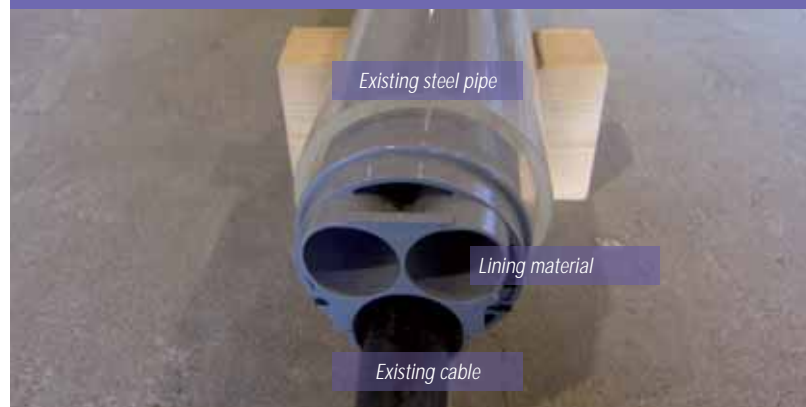
**Photo 6 — Repair technology for cable accommodation tube**

*Segmented lining*

If infrastructure is found to be deteriorating dangerously, it must be repaired or replaced. Photo 6 shows technology that can be used to repair two different types of cable accommodation tube. Using this technology, it is possible to repair and reinforce conduits that carry cables. This technology offers a way of maintaining operations at low cost.

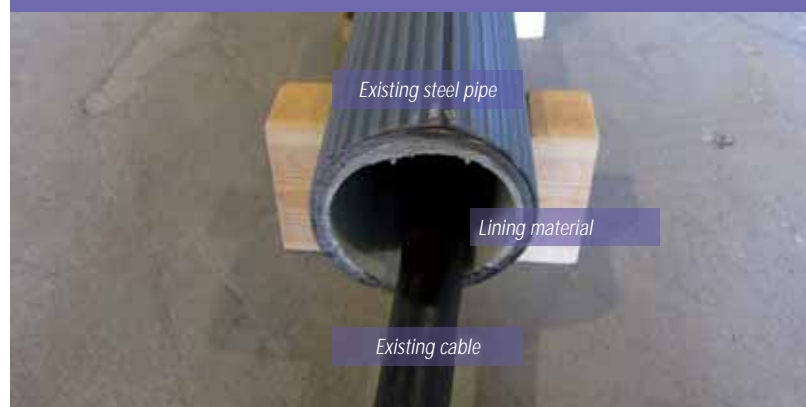
*Simple lining*
