NATURAL DISASTER EARLY WARNING SYSTEM IN ZAMBIA

PROJECT POST IMPLEMENTATION ASSESSMENT

Project Number	2ZAM15006
Project Manager	Maritza Delgado
Prepared by	Onder Cetinkaya
Date	14/04/2018

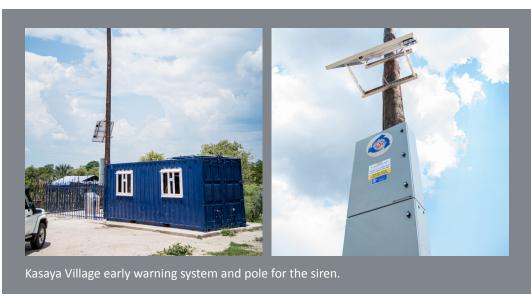
The core of the control centre is a computer equipped with the software connected to the central communication unit, which controls sirens and data collection from monitoring sensors by radio, and other hardware components serving the notification purposes.

The software evaluates the collected data, detects the status of the individual sirens within the system and activates them, monitors the operability of the communication channel, and triggers alarms and/or plays appropriate pre-recorded message in local language, depending on water levels. The control centre may work in an unmanned regime/mode and can also be controlled manually. Depending on the assumed development of emergency situation over period of time, it is possible to configure a variety of system responses.

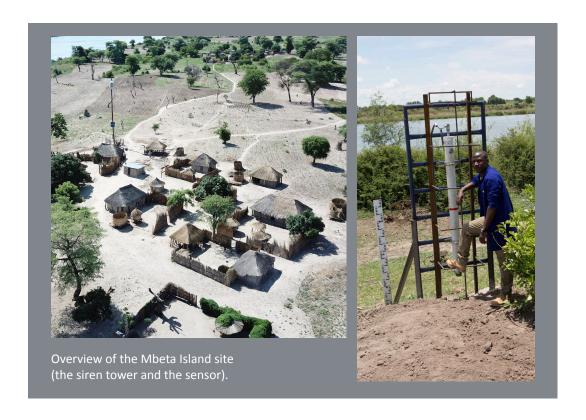
As shown in the picture, the siren in the Kasaya village has its own solar panel which feeds the siren power supply.

The same is also valid for the siren tower in the Mbeta island site. The siren tower is located on the island whereas the control center is on the main land.

Therefore, the communication between the siren and the control center is by VHF radio and the siren tower also has its own solar panel to charge the battery necessary for the operation of the siren.

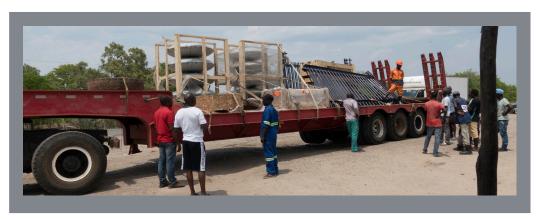
1. The weight of the system (especially the siren): The siren is an important part of the system as it is the main component that spreads the warning announcement and/or the alert sounds. The siren is effective within a radius of 5 km and functions with high pitch with enough clarity to alert the residents in the endangered area. However, the siren itself is quite heavy and bulky to transport and to erect on a tower.

Given the difficulties of transportation in accessing the concerned villages, it was a challenge for local authorities to arrange the shipping of the sirens to their destinations. Furthermore, in the case of Mbeta Island, shipment of the siren over the river was a challenge. This was sorted out with the help of the Zambian Army which used military equipment in passing to the other side of the river.

- With a view to enable ease of transportation and assembly, various alternative systems can be explored. To this end, site selection needs to be done in advance so that the most appropriate system can be chosen at the procurement stage.

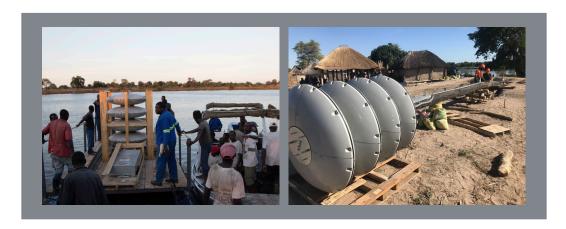
Furthermore, the sirens needed to be raised on high-rise towers installation, which normally required a crane to be present during the installation. In the case of Mbeta Island, there was no way to have a crane moved on to the island so the erection of the tower and the siren was performed manually despite of the risks involved. ZICTA engineers were successful in finding a way to manually erect the tower with the siren on it. However, it still remains as a challenge for maintenance and repair purposes in the event of a malfunction.
