Lessons and Learned

Communication Problems of the Fukushima Nuclear Power Plant No.1 Accident

Isao Nakajima, M.D., Ph.D., Ph.D.

**Researcher, the National Diet of Japan Fukushima Nuclear
Accident Independent Investigation**

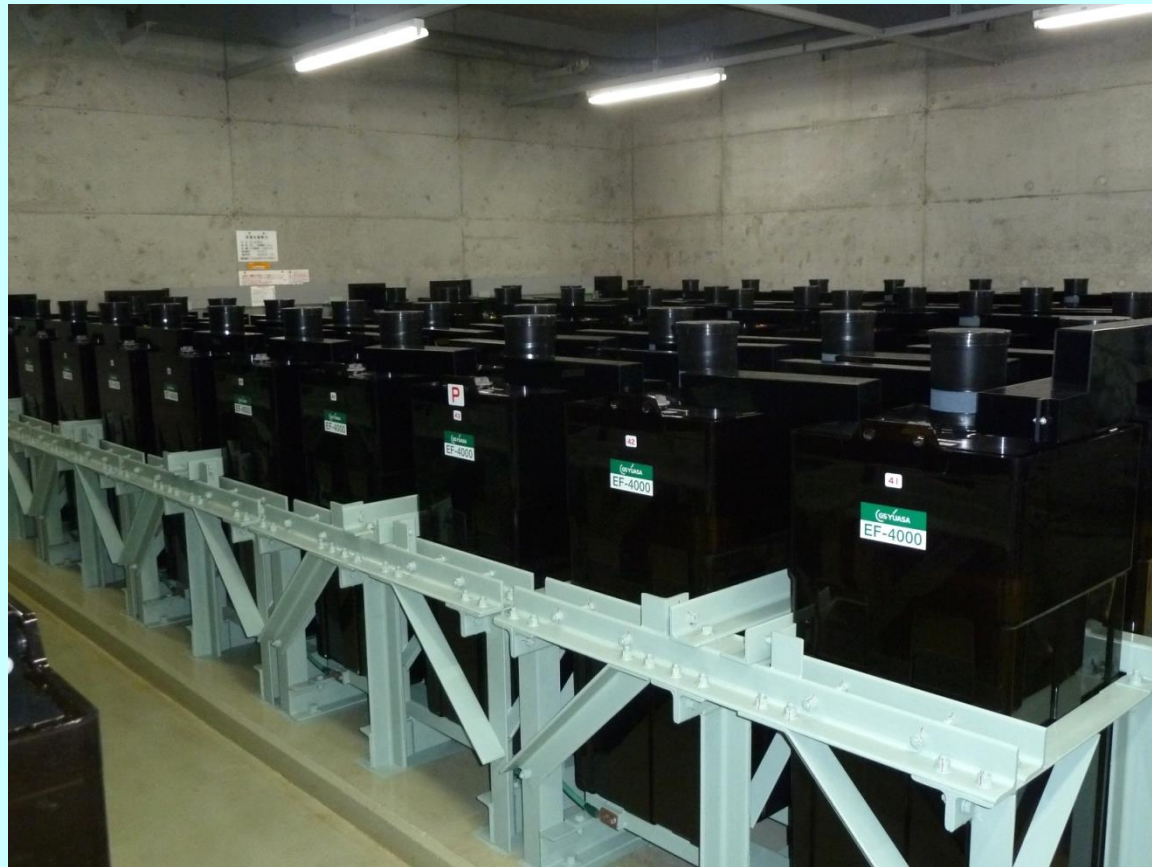
DC 115V power supply battery

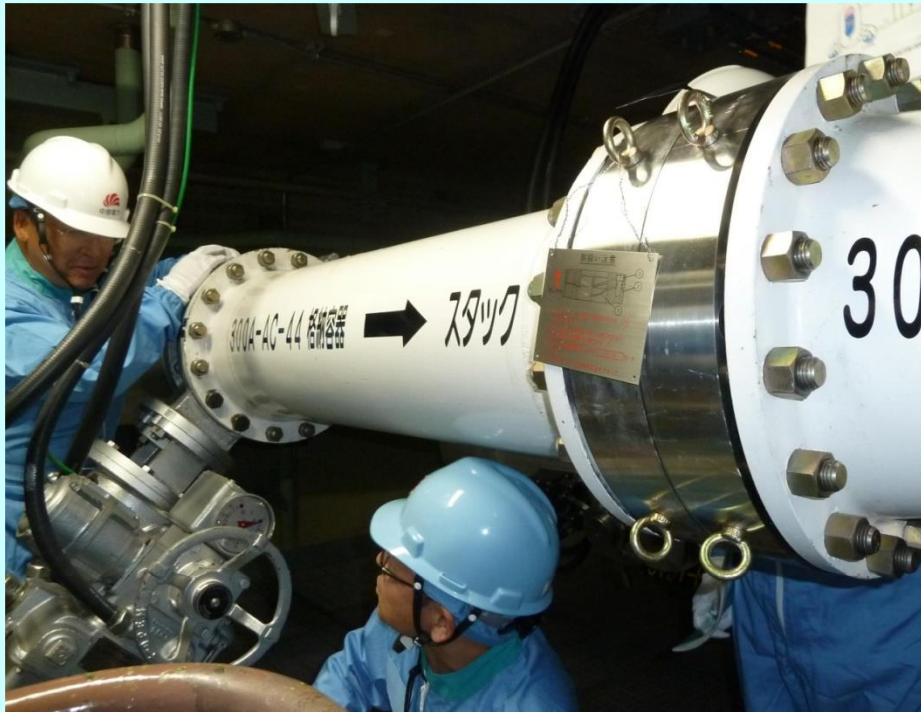
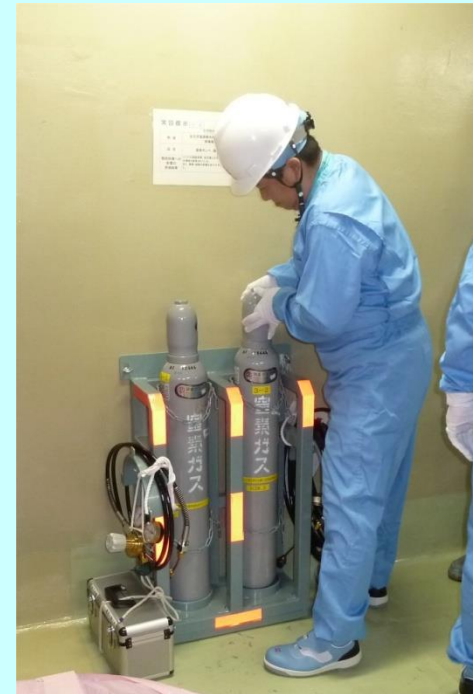
Opened AO valve by a nitrogen gas cylinder for the vent decompression

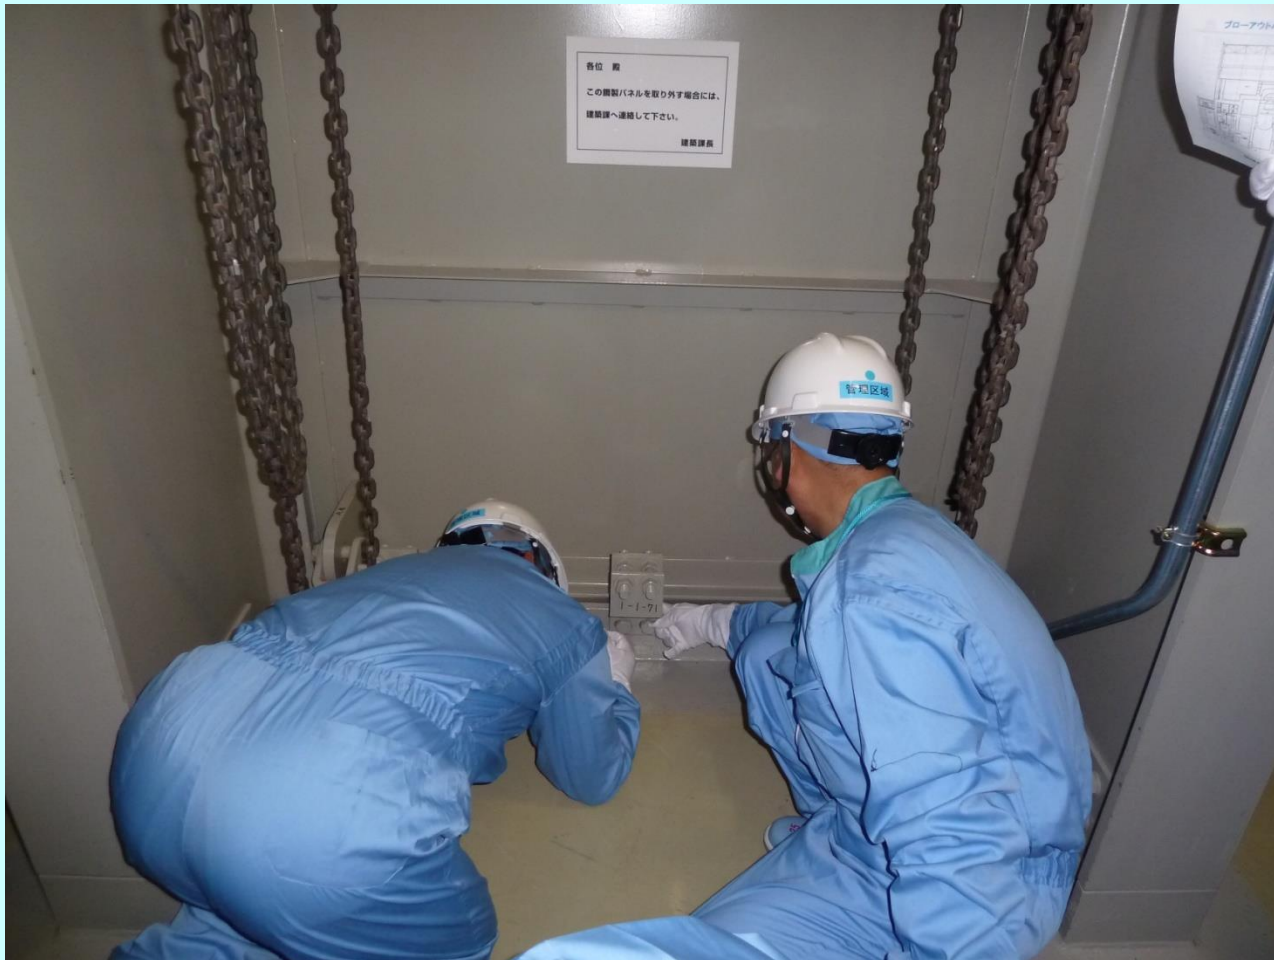
Confirmation of a blowout panel

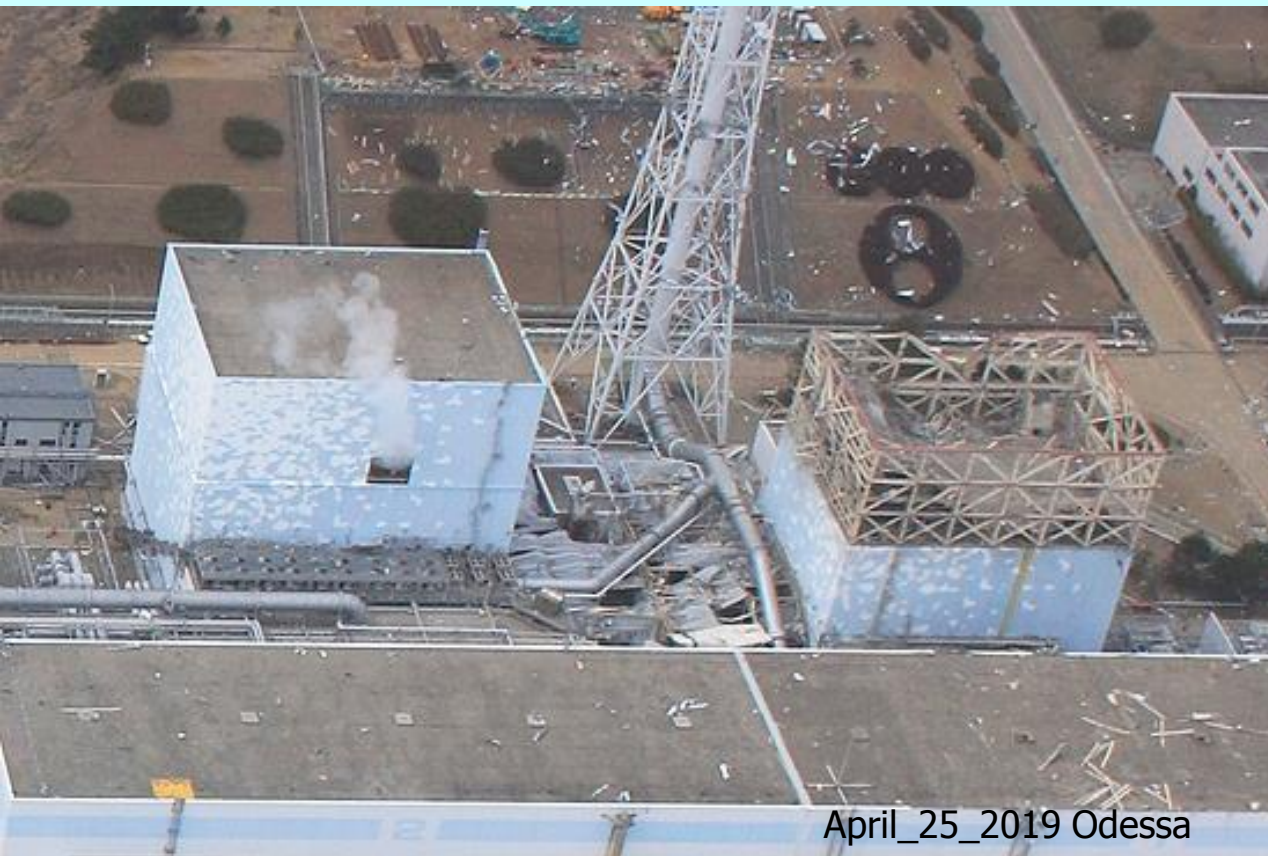
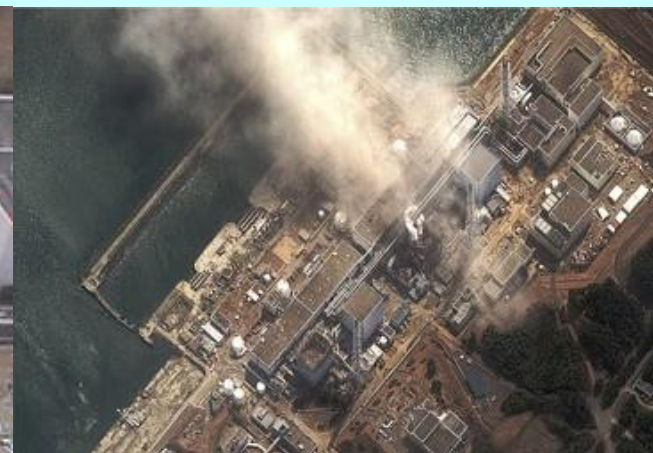
Because a blowout panel dropped naturally, the II unit #2 didn't explode

The hydrogen vent gas flowed backward from an opened valve into the I unit building and exploded several hours later.
