Case study #	2.9
Title	Malfunction of circuit breaker due to lightning surges
Type of trouble	Abnormal operation.
Source of trouble	Lightning.
System affected	Access system.
Location	Outdoors.
Keywords	Safety, immunity, lightning, power transmission line, circuit breaker, MOV.
Version date	2004-01-01

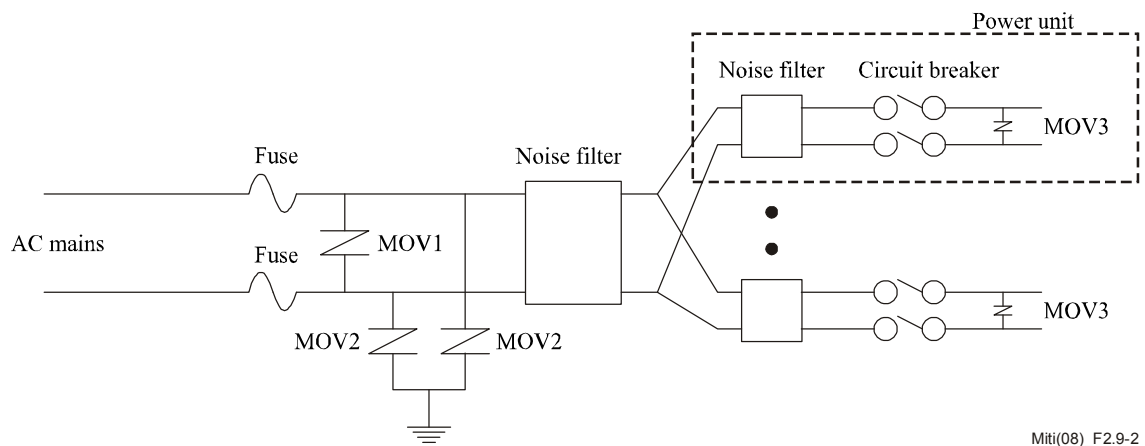
Figure 2.9-2 – Structure of overvoltage and overcurrent protection

This malfunction was caused by two mechanisms. One was the lightning surge current flowing into the circuit breaker when MOV3 operated. In the field, the 15-A fuse did not break often, but the breaker did trip. The relationship between the lightning and operation time is shown in Figure 2.9-7. A new circuit breaker, whose characteristics at the AC mains frequency were the same, was developed and the response characteristics to lightning were improved.

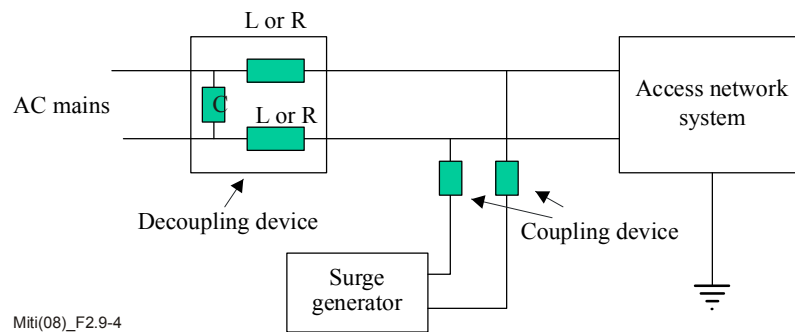
Figure 2.9-4 – Example of experimental set-up

Noise immunity and lightning surge were tested. Malfunction did not occur in the immunity test. Also, several lightning surge generators (e.g., 10/700 ITU-T and 1.2/50 combination) and coupling/decoupling methods were tested (Figure 2.9-4). It was necessary to test the coupling and decoupling units to confirm the induced waveform and current value, which depended on them (Figure 2.9-5). The results are shown in Figure 2.9-6.
