Case study #	2.9
Title	Malfunction of circuit breaker due to lightning surges
Type of trouble	Abnormal operation.
Source of trouble	Lightning.
System affected	Access system.
Location	Outdoors.
Keywords	Safety, immunity, lightning, power transmission line, circuit breaker, MOV.
Version date	2004-01-01

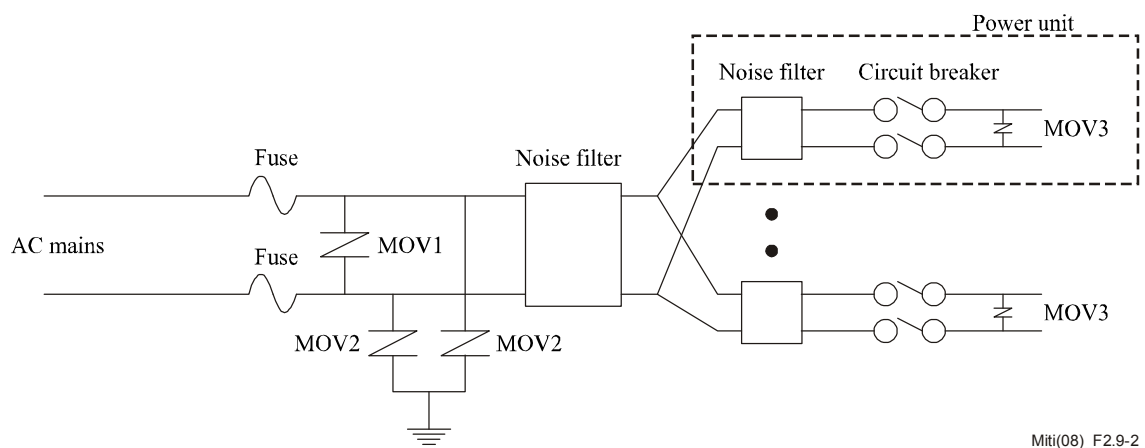
Figure 2.9-2 – Structure of overvoltage and overcurrent protection

The circuit breakers in the power units of an access network system located outdoors malfunctioned due to lightning. The access network system had an optical fibre cable, which was connected to centre equipment, a metallic subscriber cable, and an AC mains line (Figure 2.9-1). The system had four power units. Each unit had a circuit breaker, with a capacitance of 5 A at the AC mains frequency. Figure 2.9-2 shows the system's protection circuits. The power units are produced by two manufacturers. Their circuits were almost the same, but they had different malfunction occurrence probabilities.
