Mitigation measures for telecommunication installations

Part 2: Case Studies

ITU-T

2008

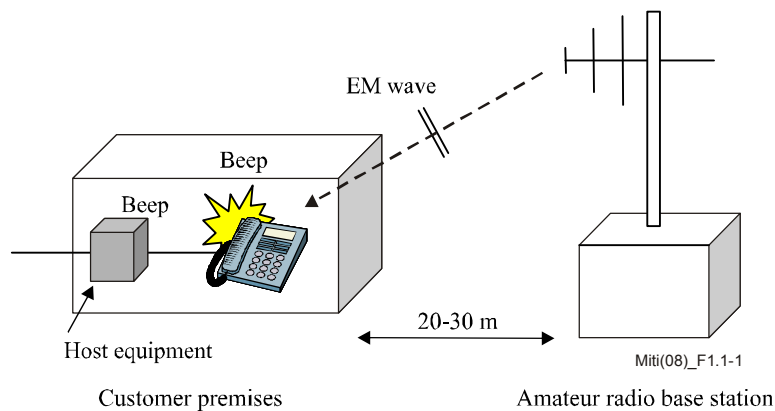
The system configuration of this issue is shown in Figure 1.1-1. The telephone set was connected to the host equipment. The customer premises were located 20 to 30 m away from an amateur radio base station. The frequency of the radio base station was 7 MHz and its radiation power was estimated at more than 100 W. After the investigations, the electric field strength was found to be greater than 110 dB μ V/m around and in the customer premises. The noise was caused by the electromagnetic waves of the amateur radio base station.

Figure 1.1-1 – System configuration

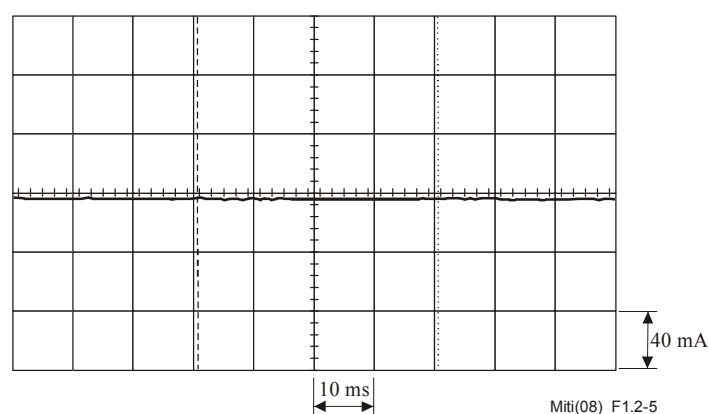
Figure 1.2-5 – Wave shape of the current in the line connected to the DSU, after the mitigation

The centre frequency of the DSU switching noise was about 10 kHz; therefore, the common-mode filter (F2-40K) for mitigations shown in Figure 1.2-4 was selected. The central frequency of the filter was 40 kHz and it was effective for the switching noise of this case. By applying the filter, the current in the line connected to the DSU was reduced, as shown in Figure 1.2-5. The current level was reduced to less than 10 mA and the acoustic noise problem was solved.

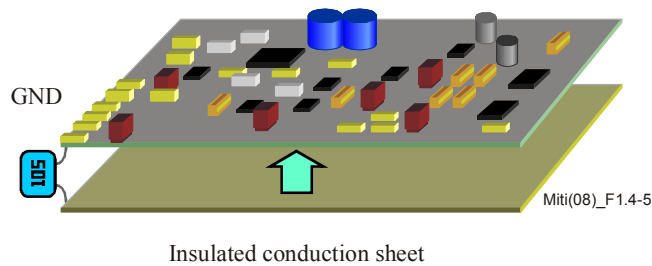
Figure 1.4-5 – Conduction sheet

- 1) An insulated conduction sheet was pasted onto the circuit board and a capacitor was put between the GND of the circuit and the sheet (Figure 1.4-5).
- 2) A ferrite bead was installed at the base of Xtal4 (Figure 1.4-6).
- 3) A capacitor was installed between VCC and GND of IC8 (Figure 1.4-7).
- 4) Ferrite cores were installed on all lines (Figure 1.4-8).

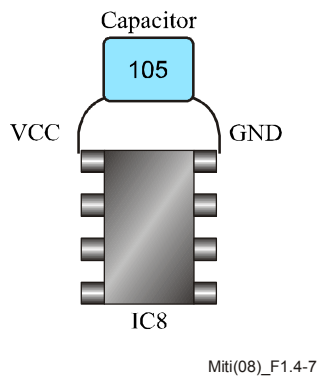
Figure 1.4-7 – Capacitor

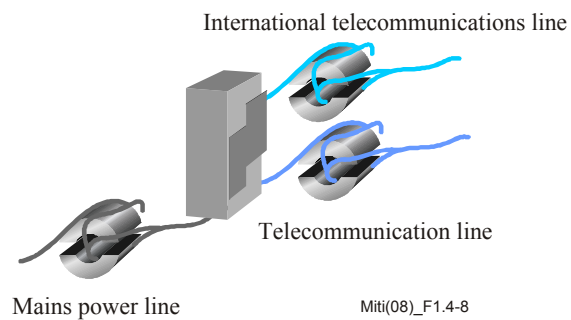
Figure 1.4-8 – Ferrite core

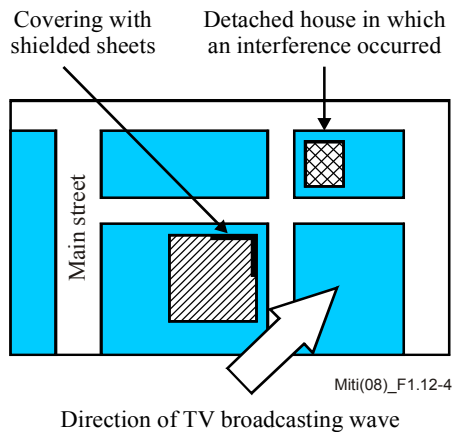
Figure 1.12-4 – Configuration of countermeasure

- covering the building wall with shielded sheets (see Figure 1.12-4), and
- clamping ferrite cores on cables connected to the transmission equipment.

After taking these countermeasures, the level of the interference signal decreased from 22 dB to 11 dB. As a result, the D/U ratio became more than 40 dB and the TV interference disappeared (see Figure 1.12-5).

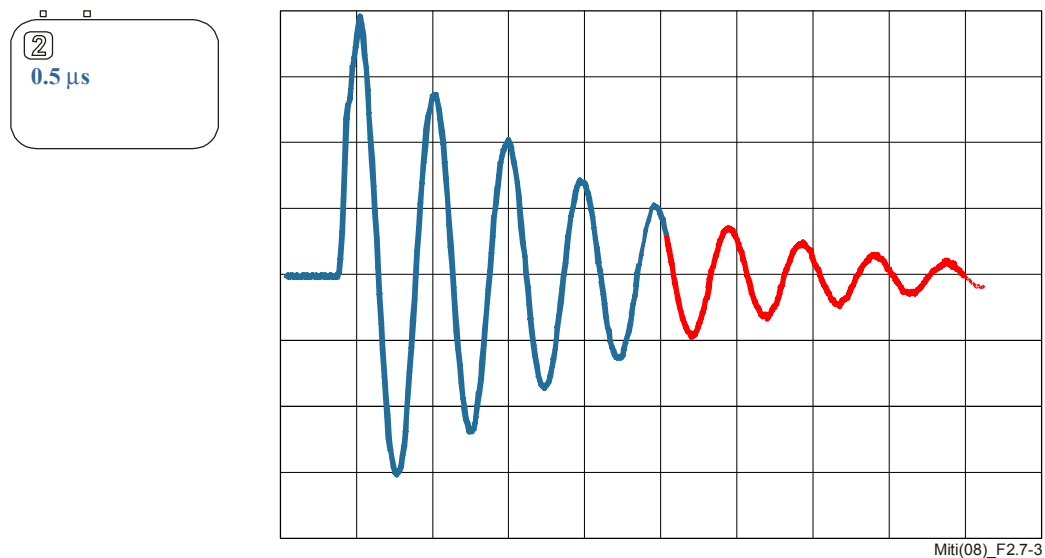
The next experiment was to check if high voltages (up to 100 kV) applied longitudinally could cause high charging currents and damage the IC due to the capacitance of the phone to earth. The charging currents did not cause damage but when one side of the line discharged to earth, the damage was replicated.

The current waveform of the current conducted transversely through the phone, when one side of the line breaks down, is as shown in Figure 2.7-3. This waveshape caused similar damage to the audio IC compared with field damaged ICs.

Figure 2.7-3 – Current waveshape entering the phone to replicate field damage

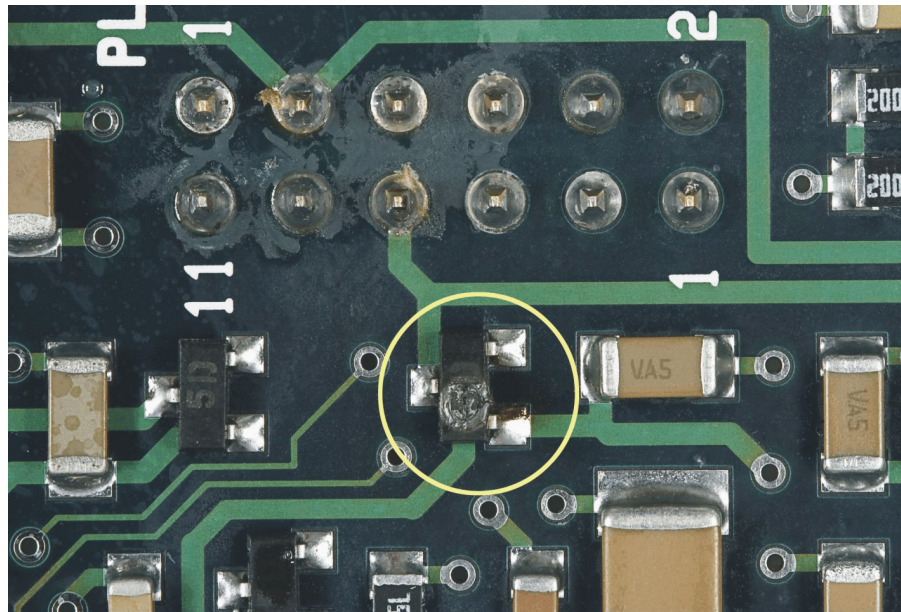
Miti(08)_F2.10-2

Damage was first identified in a couple of surface mounted diodes, see Figure 2.10-2 below, which are near the switch mode power supply connector.

Figure 2.10-2 – Picture of damaged diode

The network operator investigated damage to the external thyristor protection circuit, to the diode which clamps the incoming line to the -70 V supply rail, and to the SLIC, by electrically characterizing these components and then de-encapsulating those components with degraded characteristics and inspecting them under an optical microscope. The SLIC showed signs of significant damage consistent with "latch up" indicating that the power supply was supplying current conducted to ground via the SLIC. The thyristor protection circuit had no signs of damage.

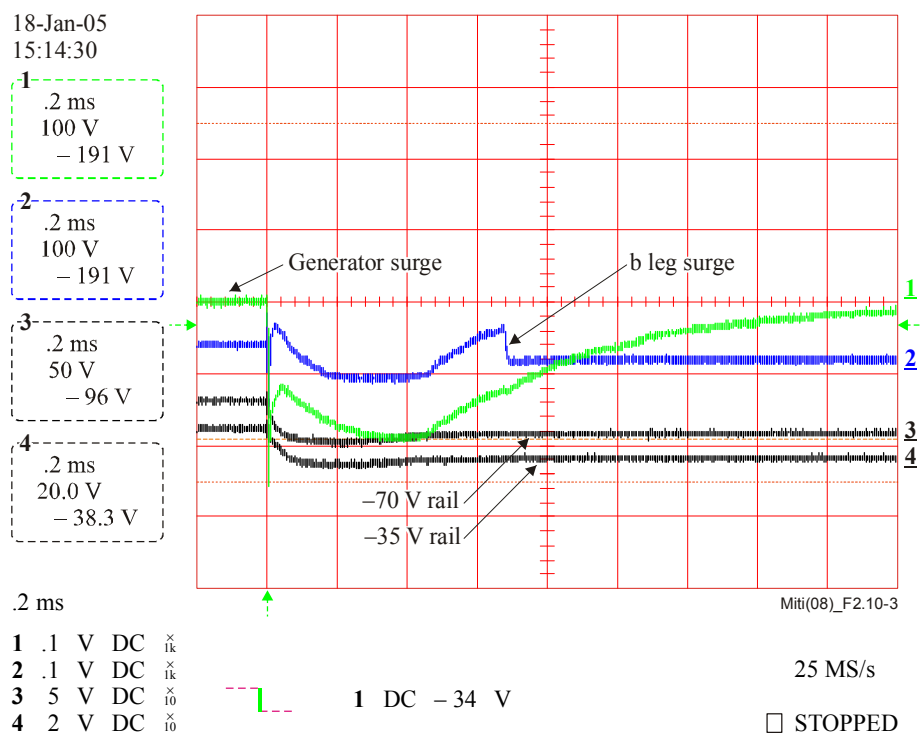
Surges were applied to a working circuit to verify this scenario. Figure 2.10-3 shows negative surges applied to an unprotected circuit. The generator surge (-191 V) causes a surge of -100 V on the b leg of the circuit. The difference of 91 V is due to the voltage drop on the coupling metal oxide varistor (MOV). The surge has caused the -70 V rail to be driven more negative (-70 V to -96 V). After a few surges, permanent damage has occurred.

Figure 2.10-3 – Waveforms during a damaging surge

The failure appears to be caused by a negative surge entering under the firing voltage of the thyristor protection circuit (± 190 V) and causing the -70 V and the -35 V rails to become more negative by the current entering the power supply via the diode which clamps the incoming line to the -70 V supply rail. When the -70 V rail is surged to approximately -100 V and the -35 V rail is surged to approximately -45 V, the SLIC latches up and the current is conducted from the -70 V and -35 V rails to ground, see Figure 2.10-4, which shows the current path through the thyristor protection circuit and the diode to -70 V, and the current from the -70 V and -35 V rails through the SLIC. It is the power supply current that damages the two diodes which connect from the -35 V and -70 V supply lines to the SLIC circuit (based on the fact that the diode which clamps the incoming line to the -70 V supply rail is not damaged).

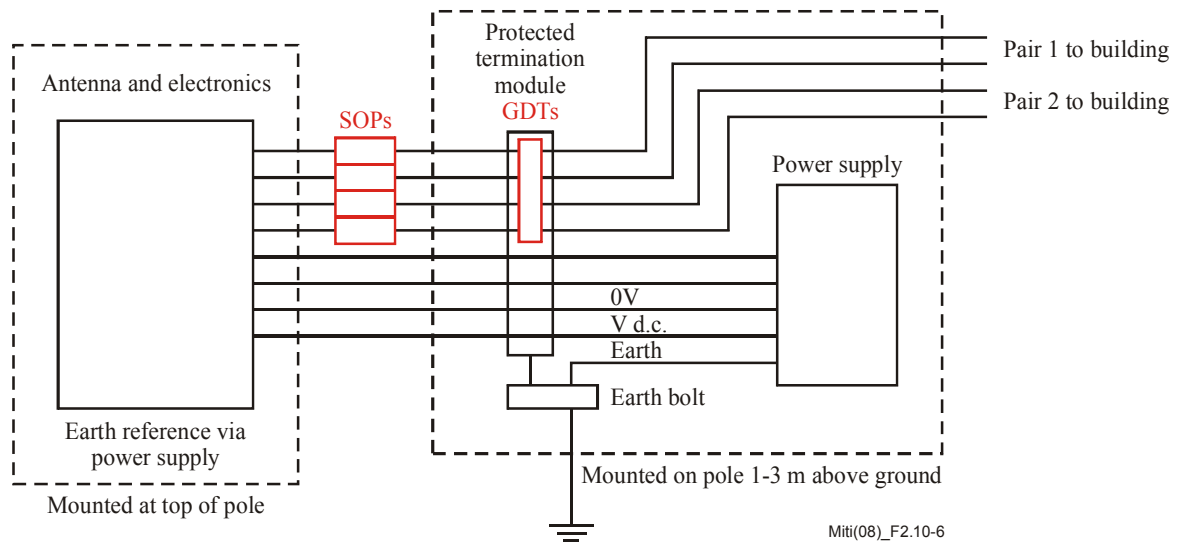
Figure 2.10-6 – GDT and SOP protected system

Tests performed indicate that the SOP will protect the circuit. Because the SOP limits the current to 200 mA, it prevents both the –35 V and the –70 V power supply voltages from being forced negatively. Figure 2.10-6 shows the new circuit configuration.

A field trial, where one of the two circuits was protected by a GDT and the SOP, has proved the success of the proposed protection. Within a few weeks of the installation, a lightning storm damaged the circuit protected by a GDT whereas the one protected by the combination of a GDT and the SOP continued to operate.
